MARQUETTE INTERCHANGE PIER TS7

QA/QC Lessons
Learned, Case Study

Tony F. Shkurti, PhD, SE, PE

HNTB

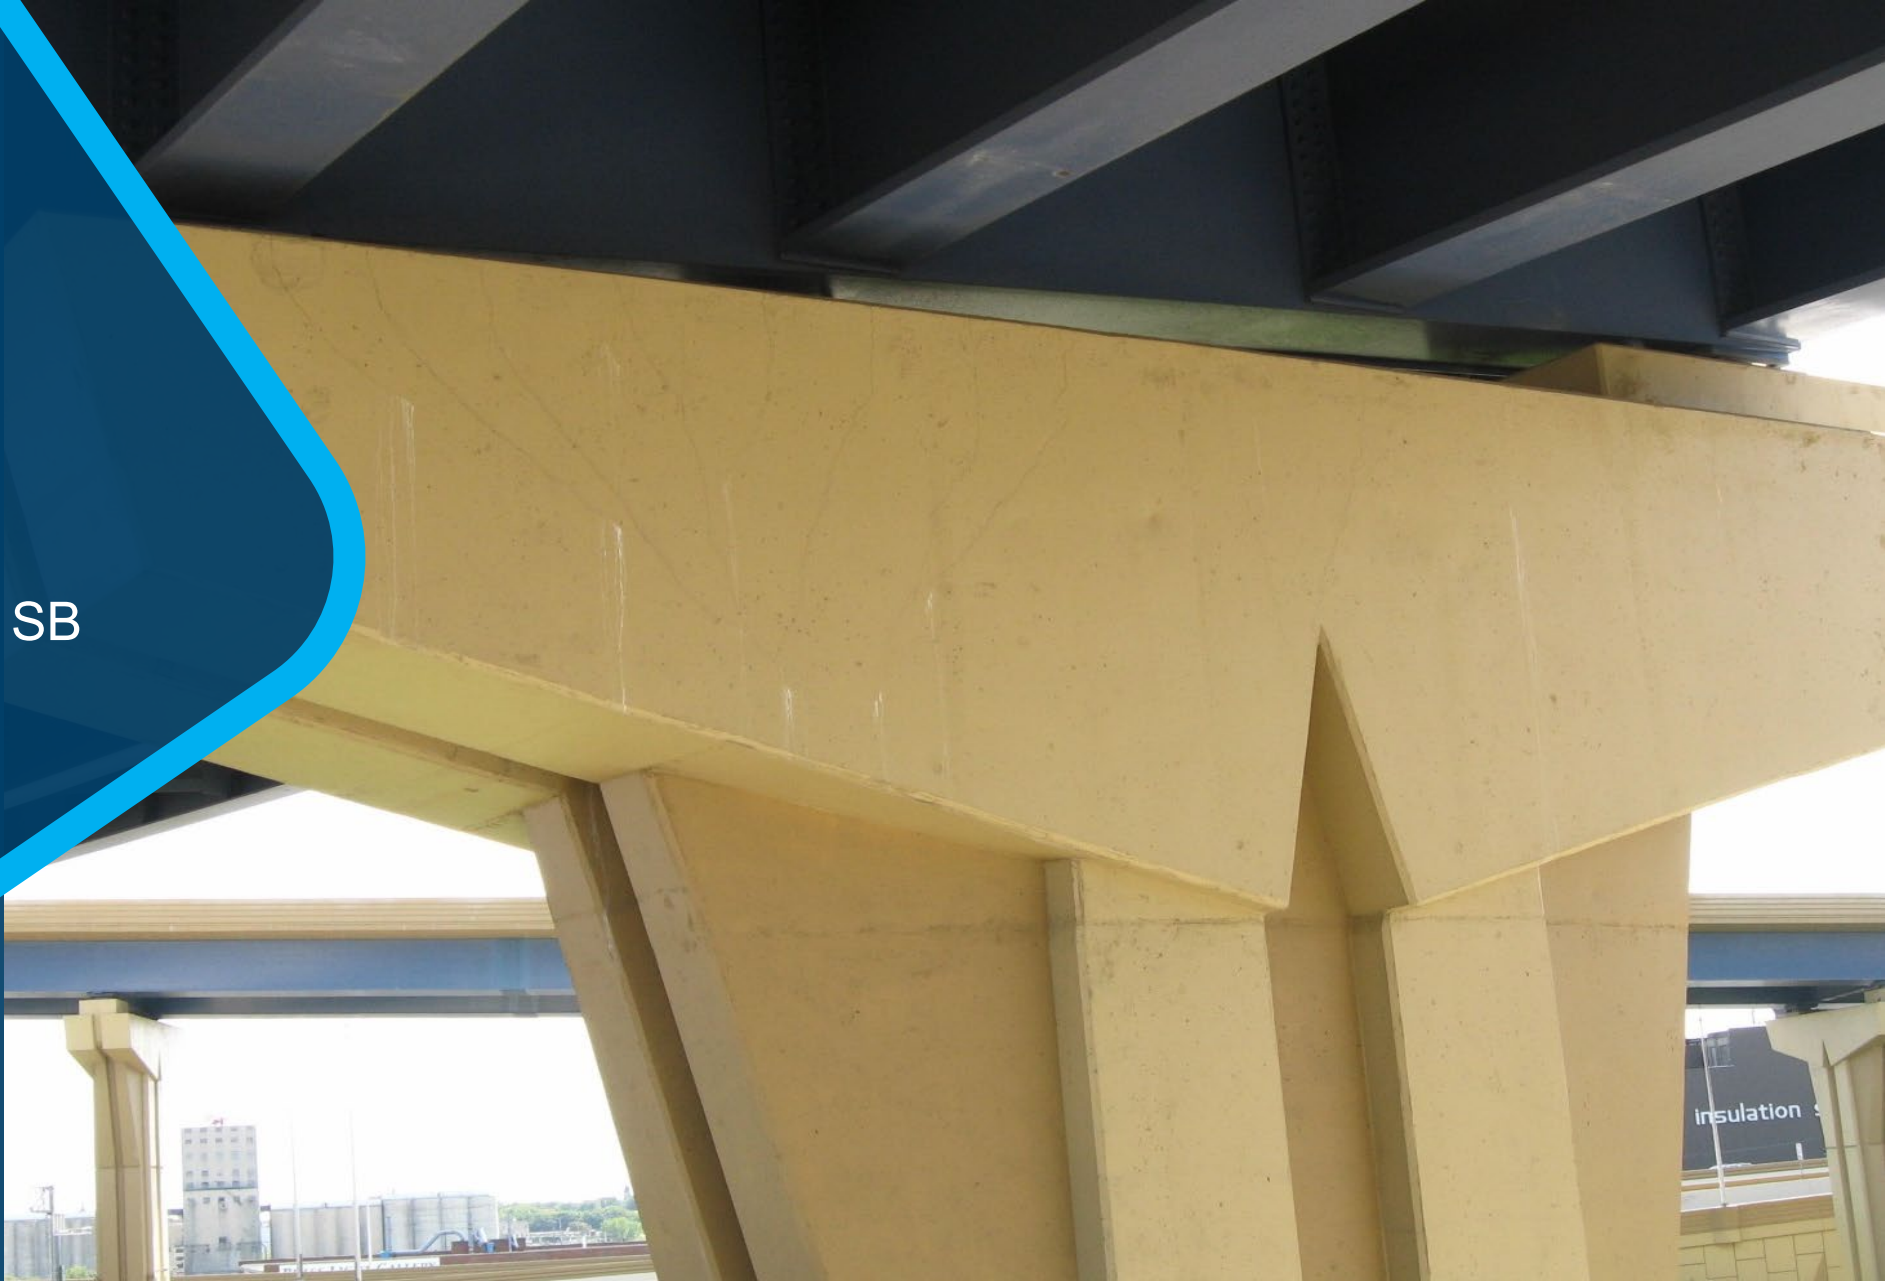
BIANNUAL INSPECTION: PIER TS7 HAS A PROBLEM

- B-40-1231-001,
Wisconsin Ave to I-43 SB
over N-E Ramp North
Face of Pier TS7

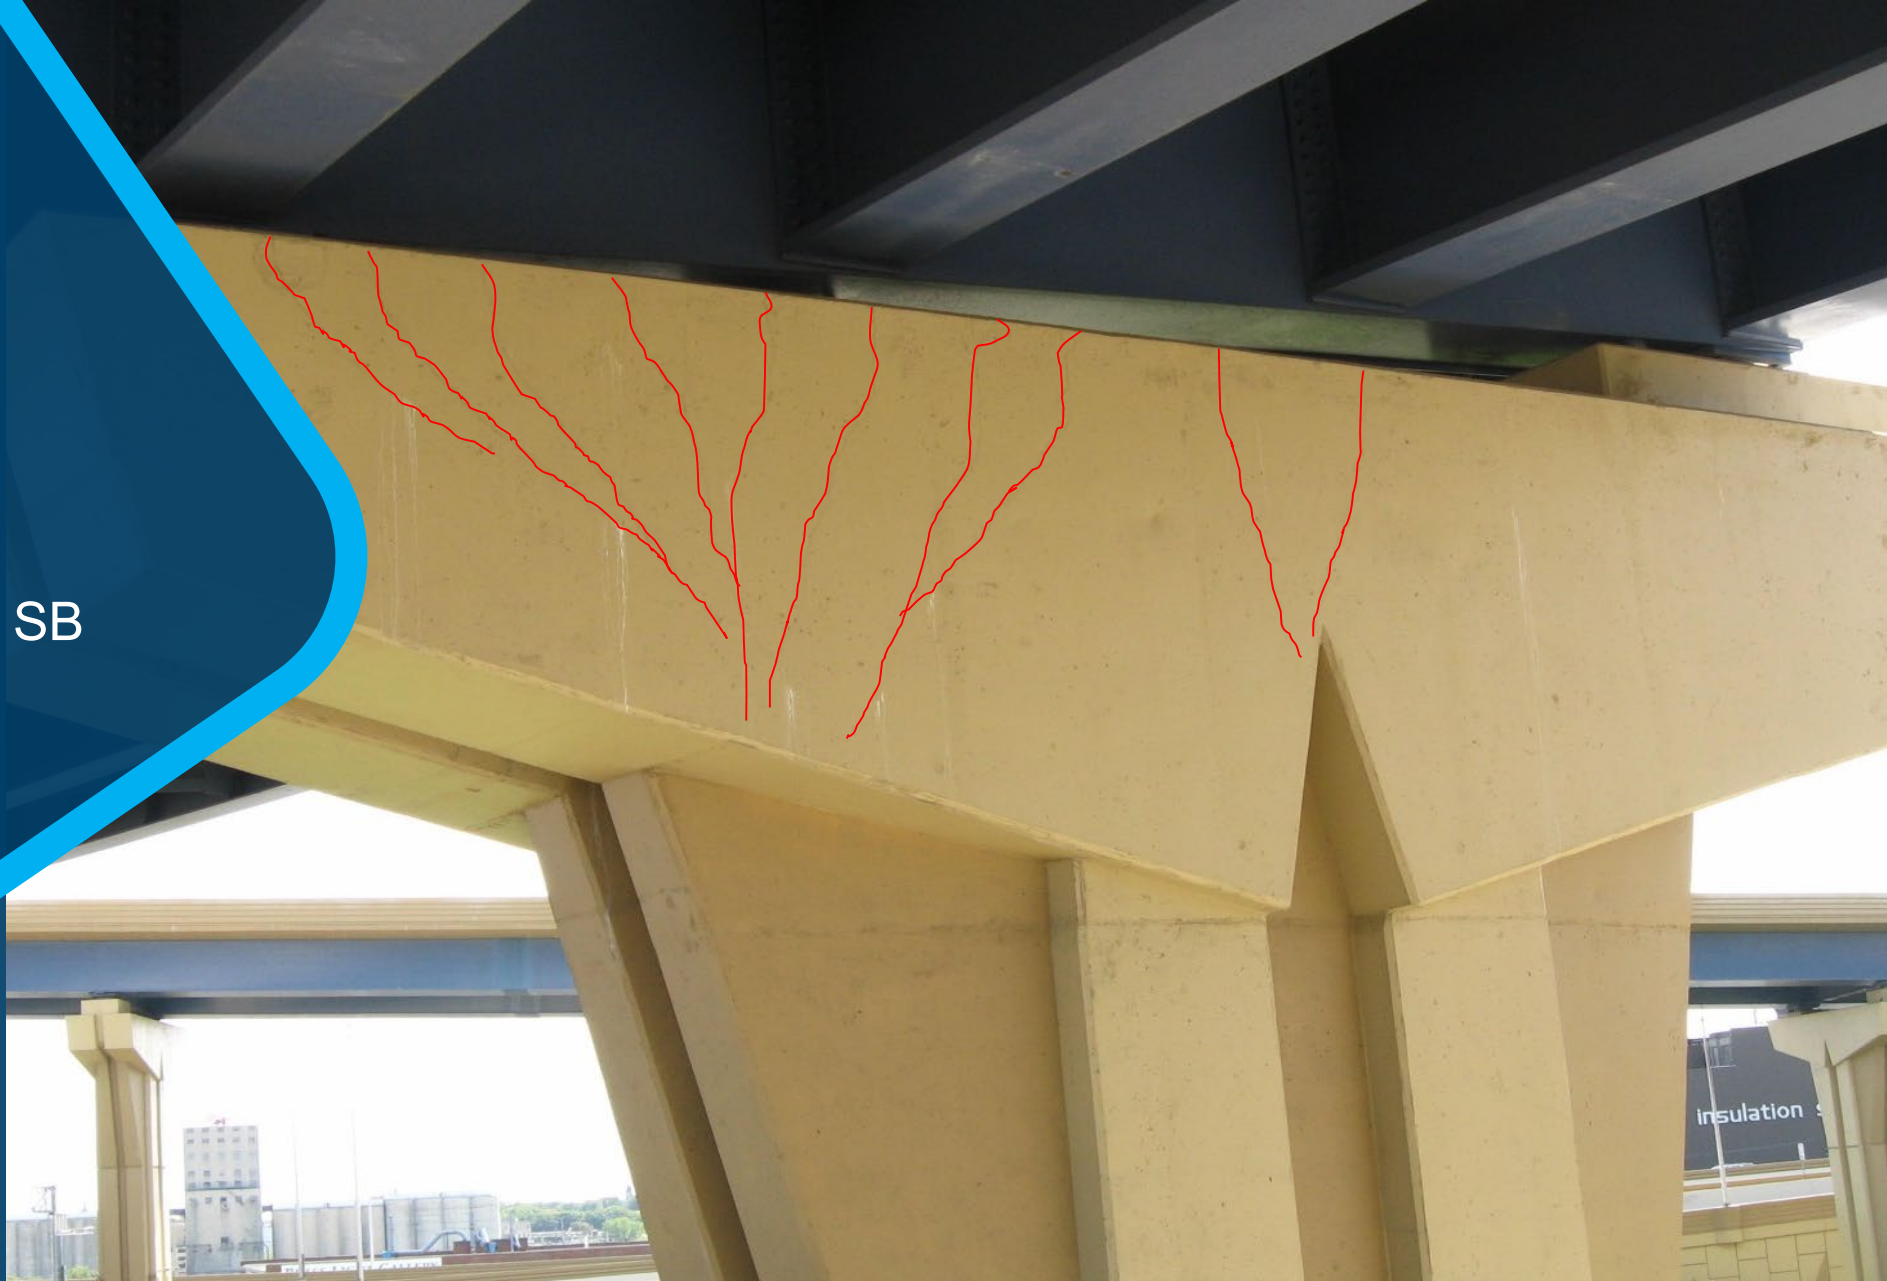
BIANNUAL INSPECTION: PIER TS7 HAS A PROBLEM

- B-40-1231-001,
Wisconsin Ave to I-43 SB
over N-E Ramp North
Face of Pier TS7

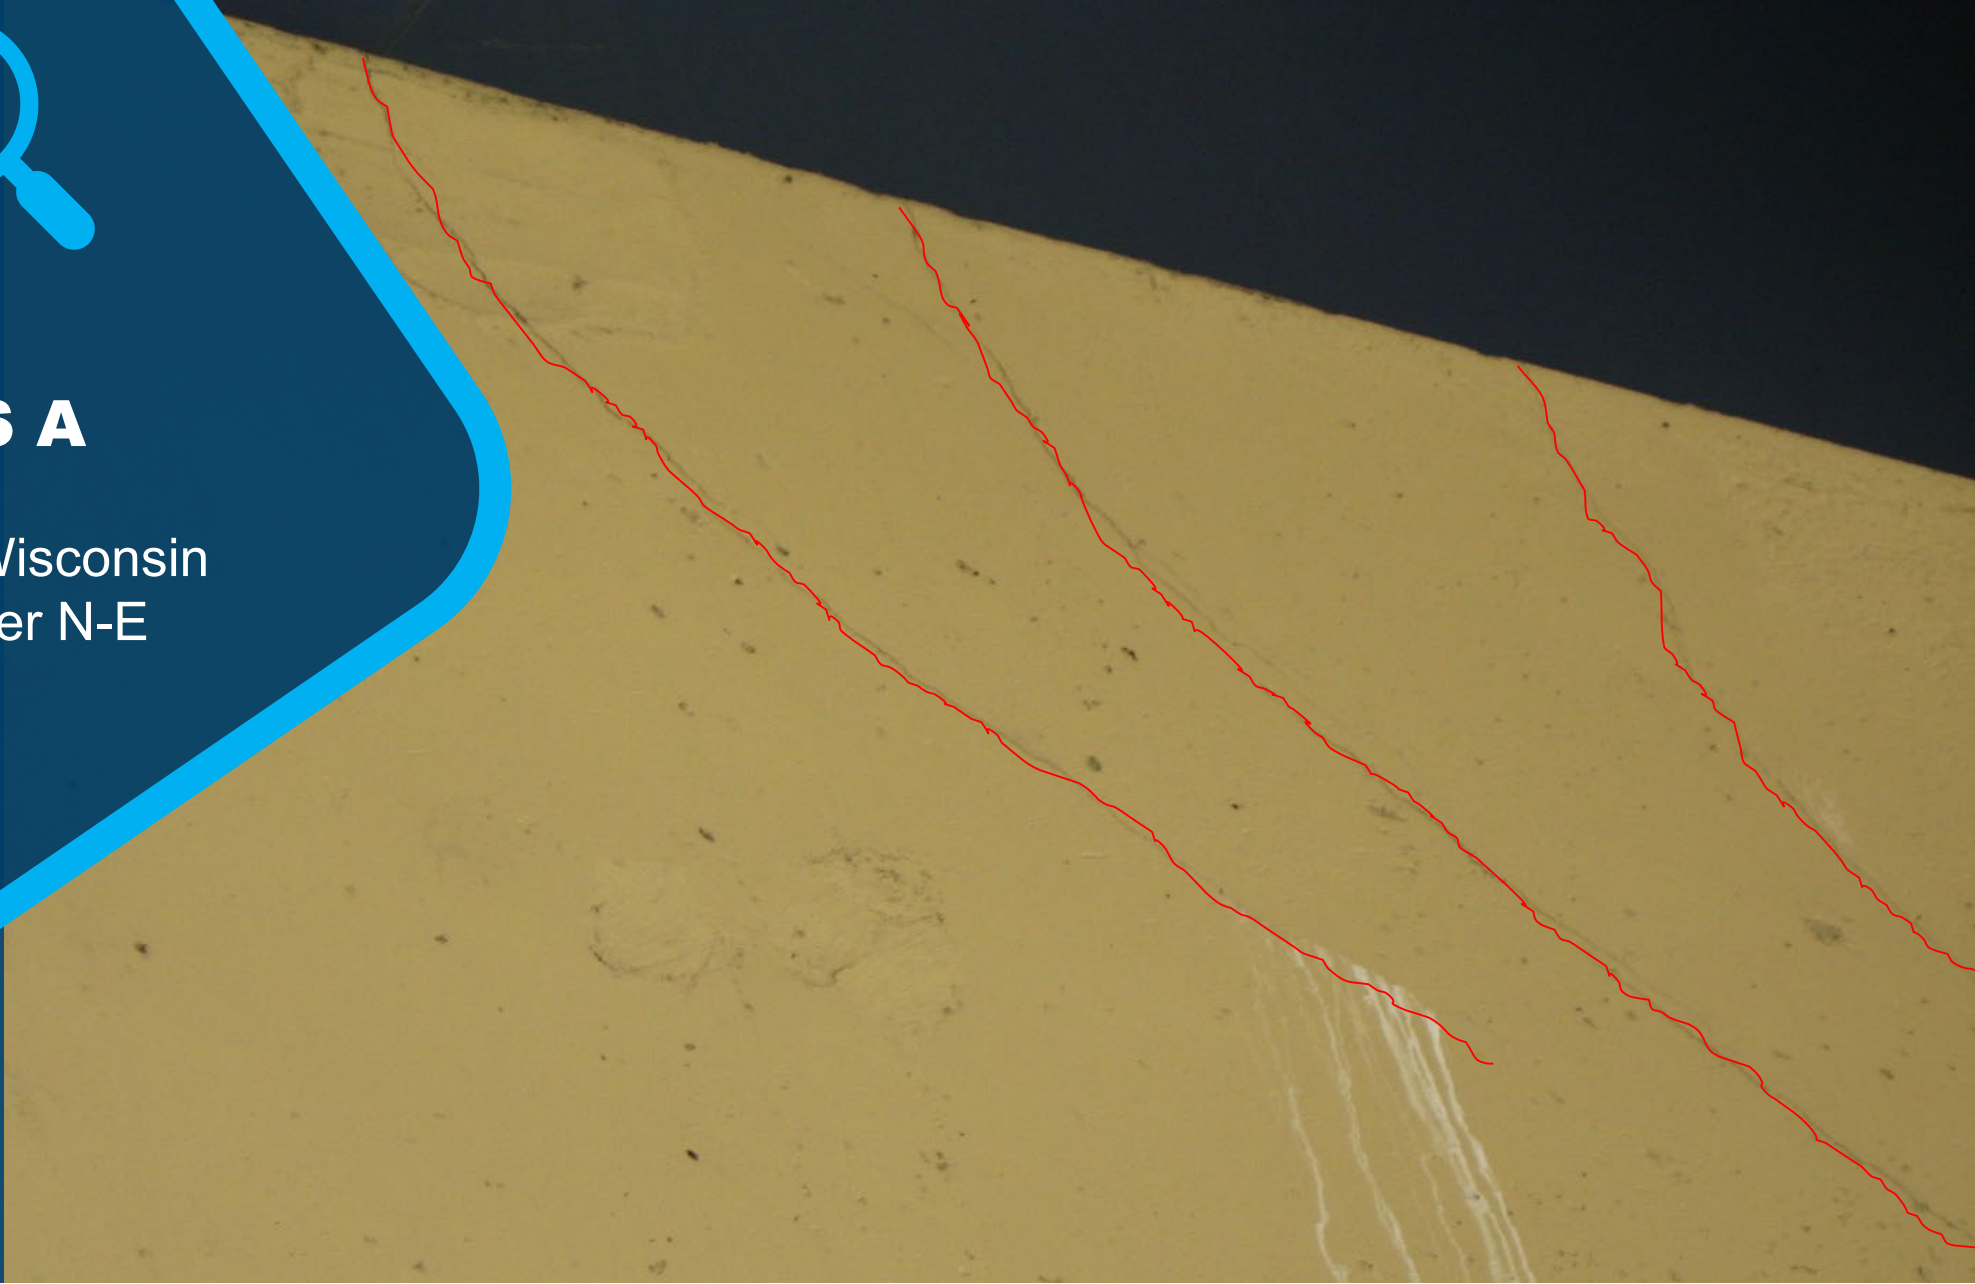
BIANNUAL INSPECTION: PIER TS7 HAS A PROBLEM

- B-40-1231-001, Wisconsin Ave to I-43 SB over N-E Ramp North Face

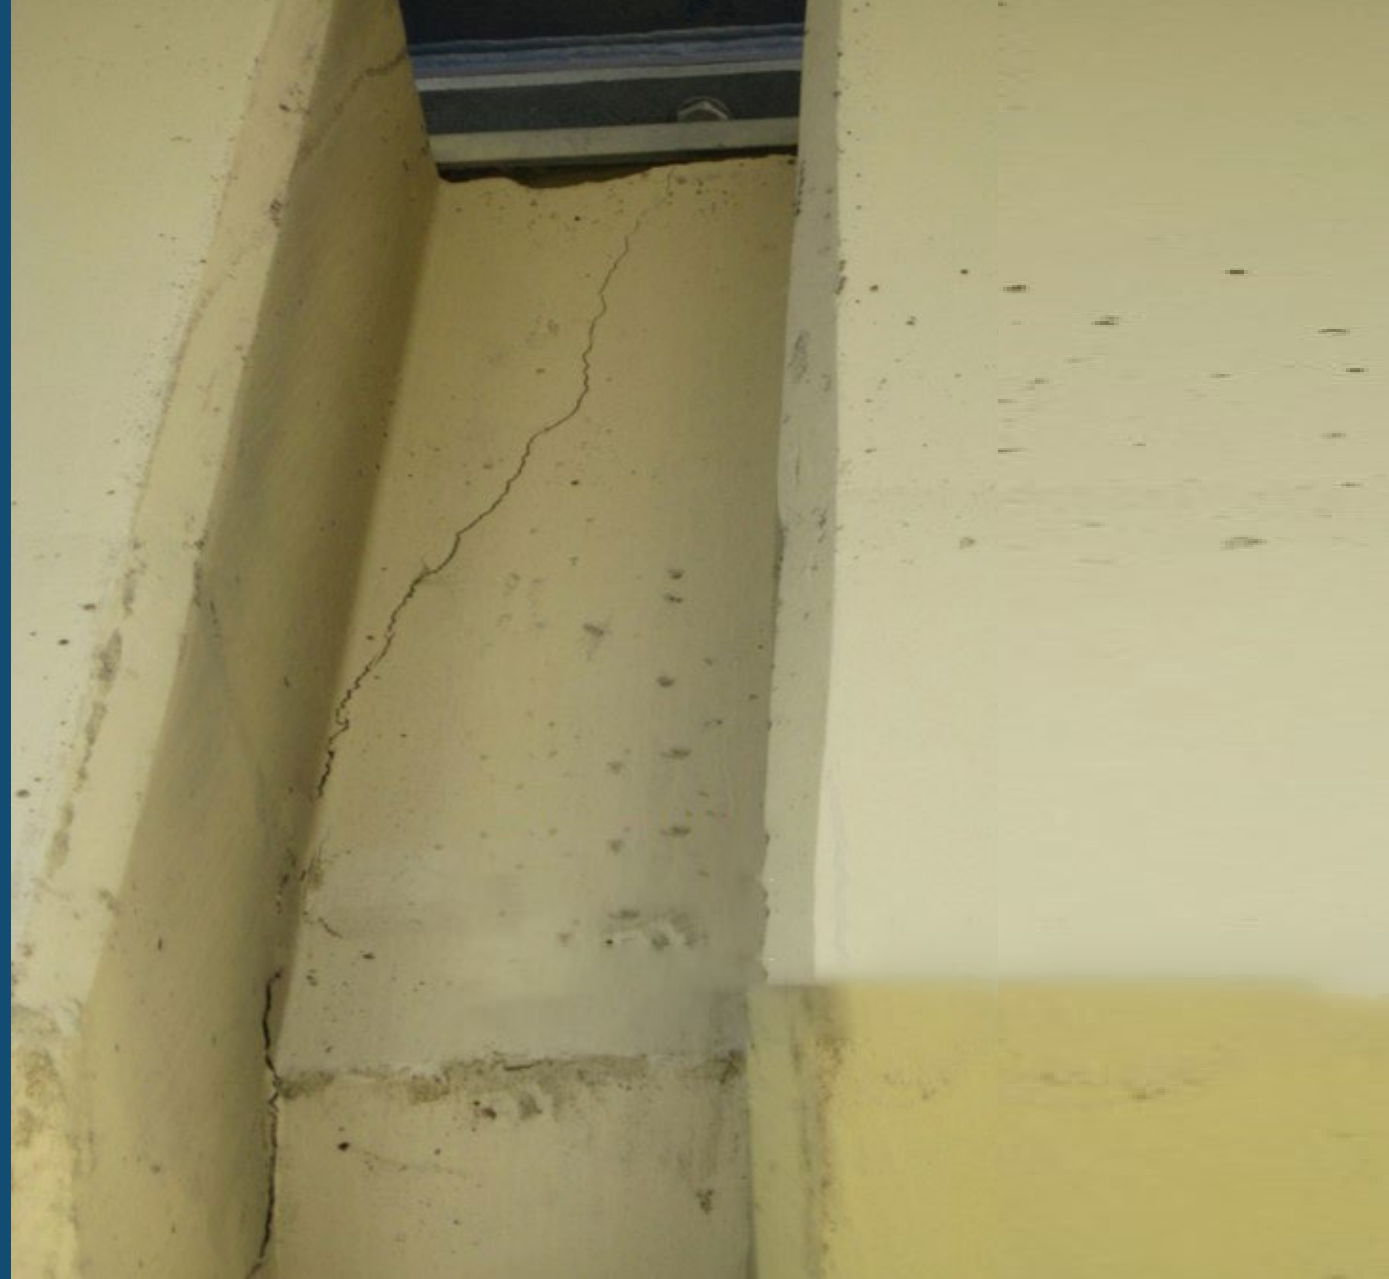
BIANNUAL INSPECTION: PIER TS7 HAS A PROBLEM

- B-40-1231-001, Pier TS7
Vertical Crack, East Face (note
location of Pot Bearing

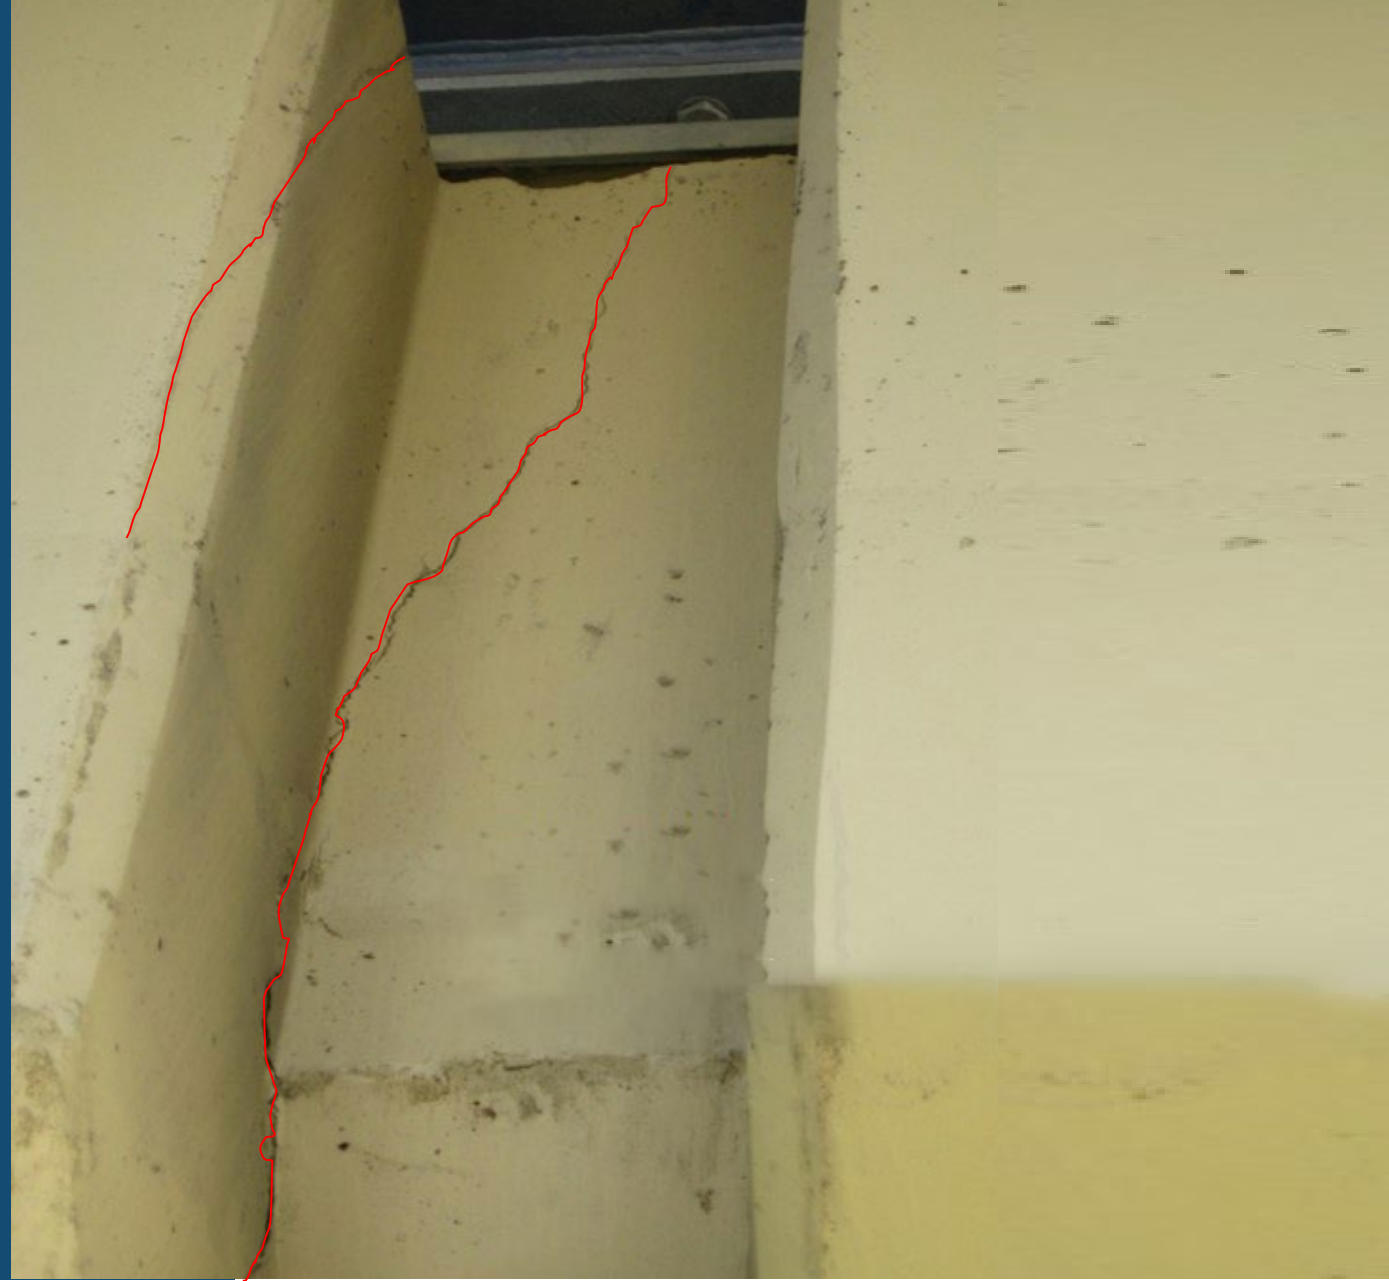
BIANNUAL INSPECTION: PIER TS7 HAS A PROBLEM

- B-40-1231-001, Pier TS7
Vertical Crack, East Face (note
location of Pot Bearing

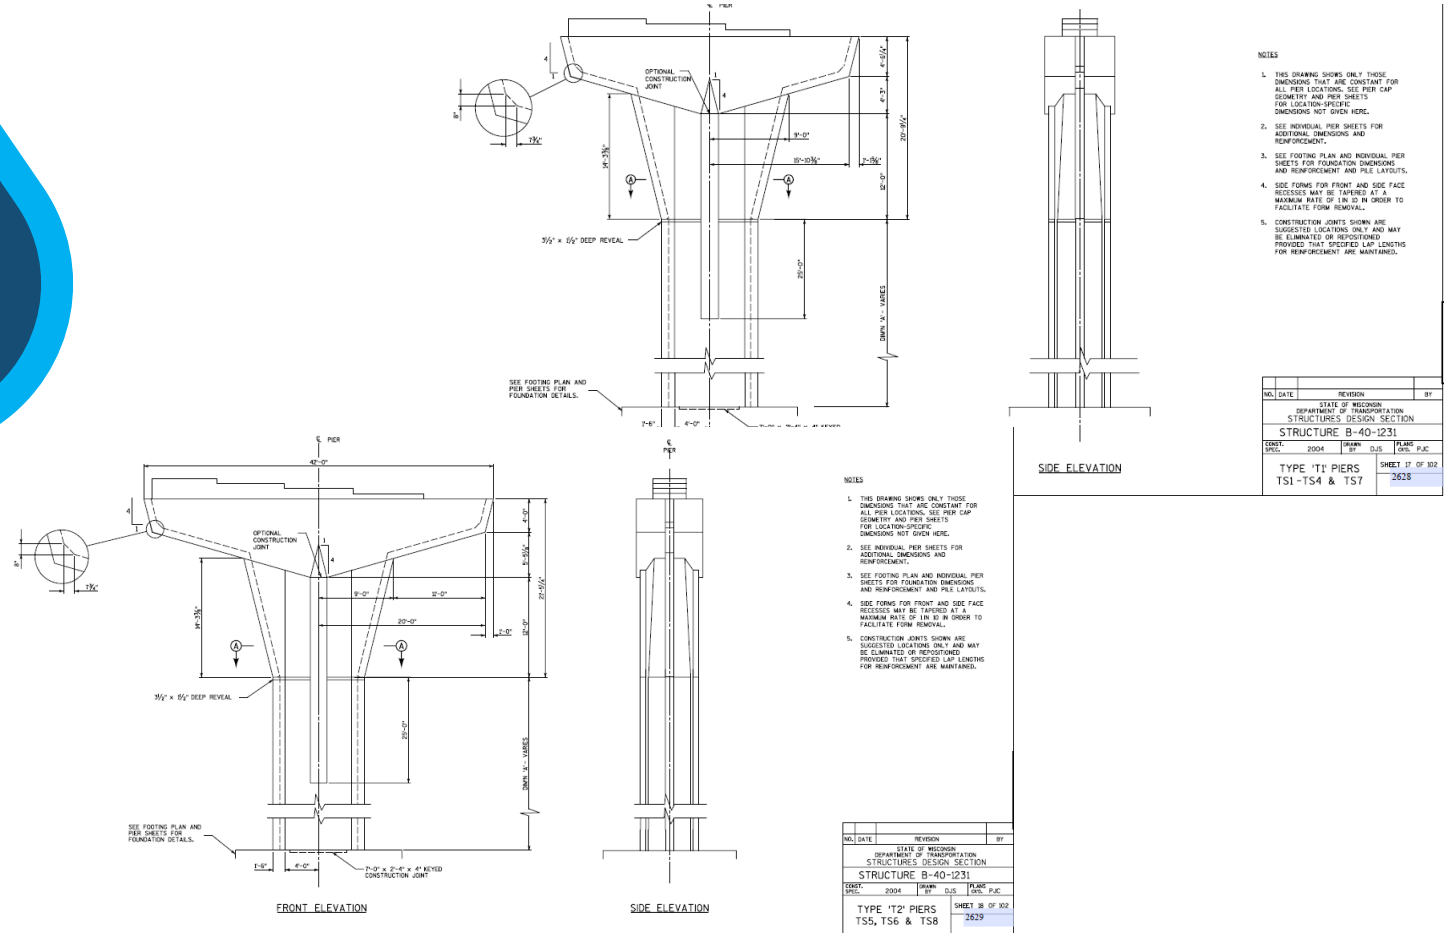
THE ISSUES WITH PIER TS7:

Oooops...maybe, maybe wrong grouping

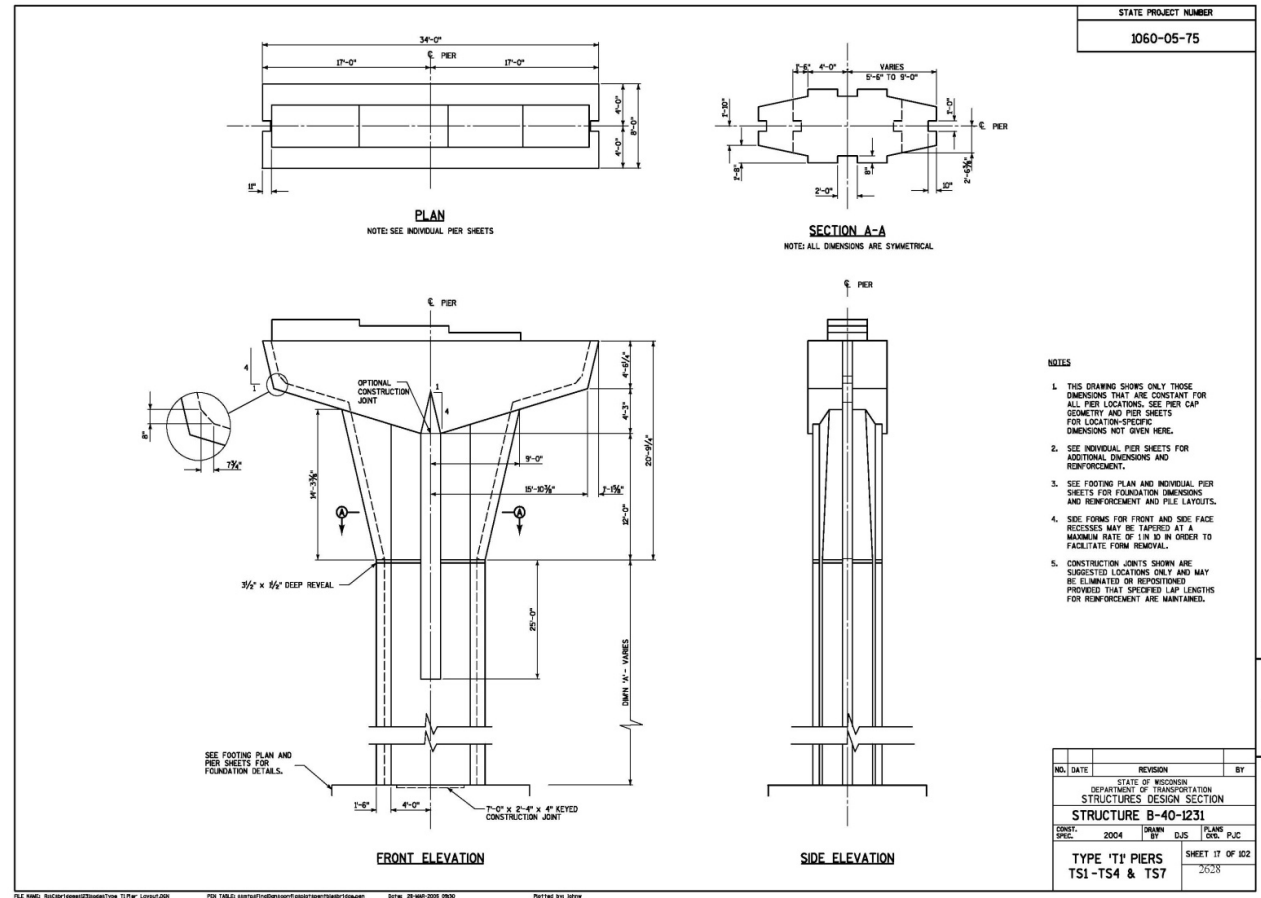
THE ISSUES WITH PIER TS7:

Ooops...maybe, maybe wrong grouping

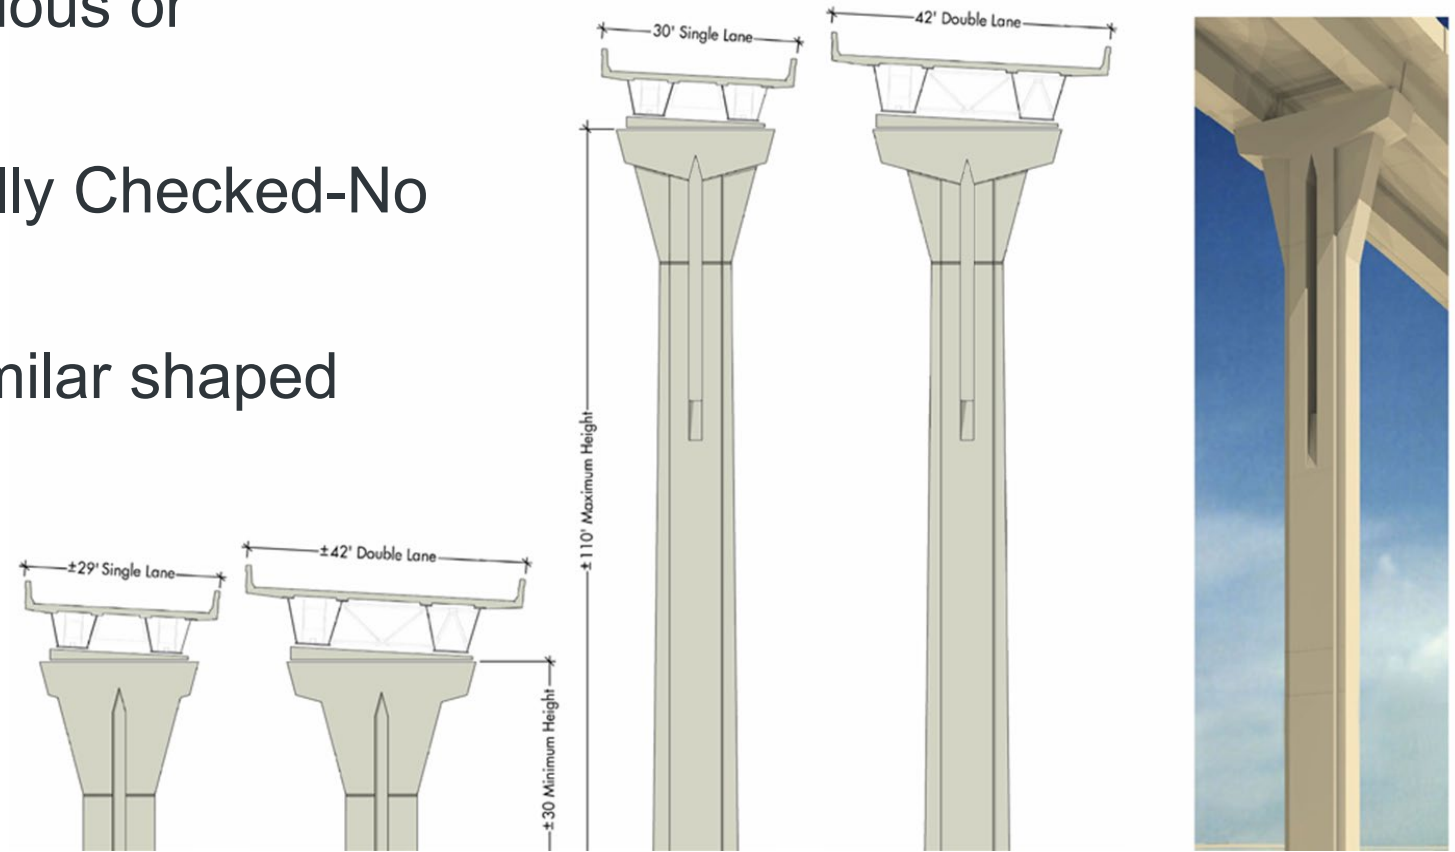
How Did this Happen? Column Grouping

- Column Grouping not Obvious or Transparent
- Individual Pier Designs Fully Checked-No Unique Design for TS7
- Goal: Simplify plans for similar shaped piers-Big miss on Loading

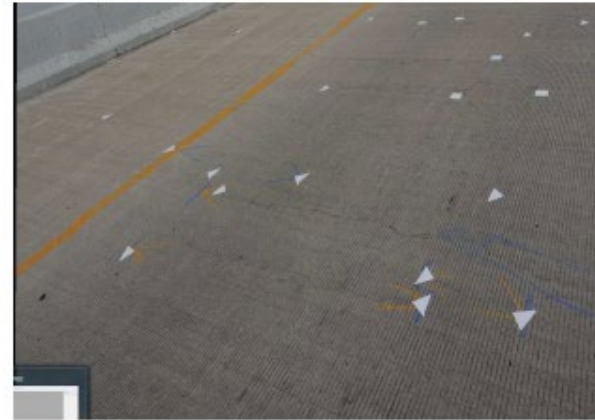
RAW IMAGE FROM SCANNER

- Monitor Deck Cracking before and after Jacking
