HIGH FRICTION SURFACE TREATMENT (HFST) I-57 and I-74 Interchange

101st IL Transportation and Highway Engineering (T.H.E.) Conference - February 24, 2015

Contract 70A52 HFST project Ramps at I-74/I-57 interchange

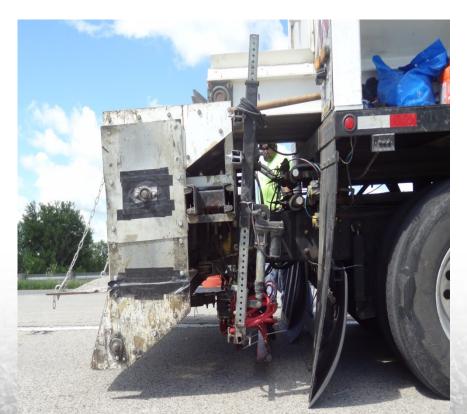
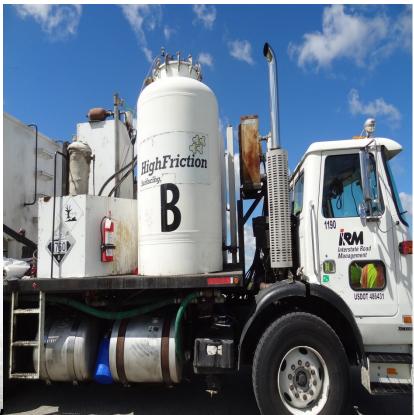
Special Provision for HFST - Equipment: Fully Automated Truck Mounted Application

Fully Automated Truck Was Used Resin Applied Spray Bar (12 ft. Wide) Mounted on Truck, and Bauxite Dropped from Drop Box Resin Stored in Tanks on Truck; Applied @ 3,5 Sq. Yd. (max.) / Gallon Resin (15 Gallons / Minute)

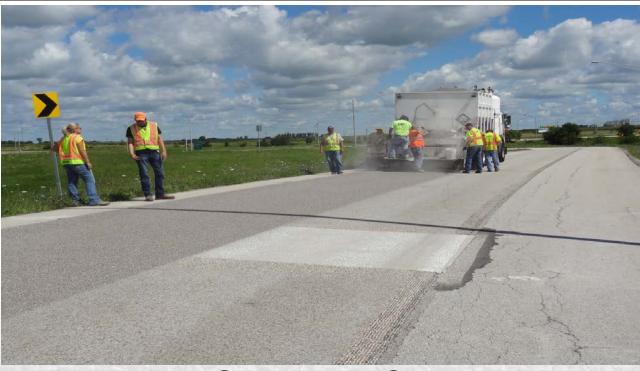
Special Provision for HFST – Pavement Preparation

- Must Have Structurally Sound, Moisture
 Free Pavement
- Full Depth Concrete Patch
- Clean and Seal ¼" 1 ¾ " Wide Cracks)
- Removal of Pavement Markings

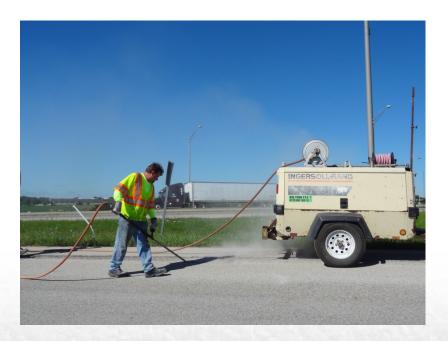
Special Provision for HFST - Equipment: Shot Blasting and Regenerative Air Sweeper (RAS)

- Remove Curing
 Compound
- Crack Cleaning

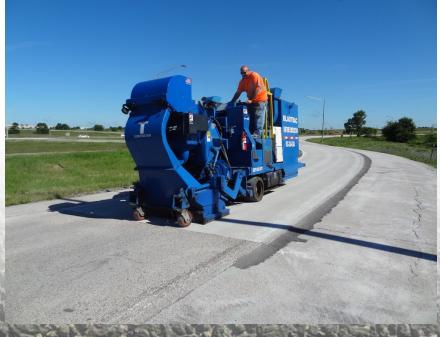
Pavement Cleaning Using RAS Power Broom - Initial, Second & Final Sweeping

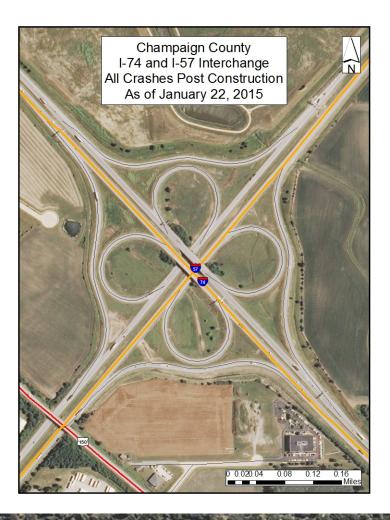
I-57 and I-74 Interchange Crash Totals – Crash Data Comparison of 08-13 thru 01-14 to 08-14 thru 01-15

- Pre HFST: 7 Total Crashes Reported (August 2013 – January 2014)
- Post HFST: <u>0</u> Total Crashes Reported (August 2014 – January 2015)

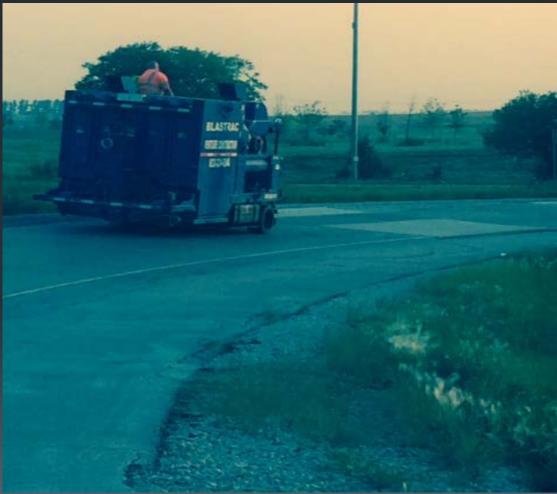
Preparation for HSFT Shot Blasting

- All Concrete
- Test HMA section
- Areas of stains and roadway buildup

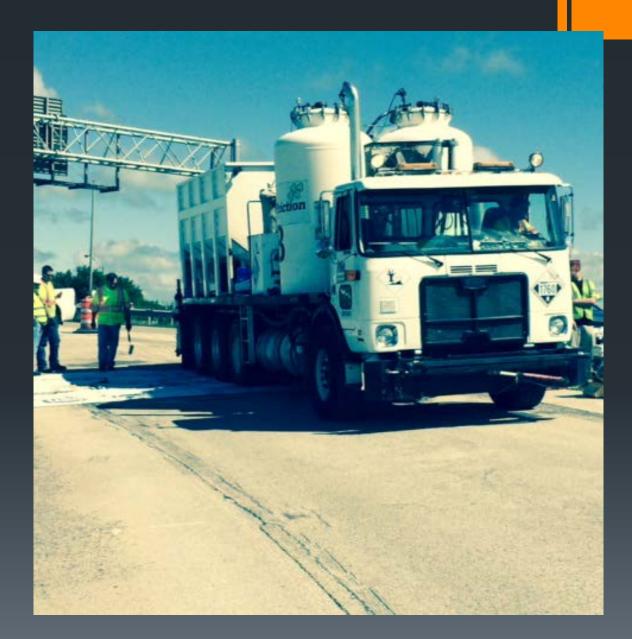
Truck Mounted Application Machine

Required to place

Resin at a minimum rate of **15 gal/min**

Aggregate at a minimum rate of **13lb/sq yd**

varying widths of **up to 12ft**.

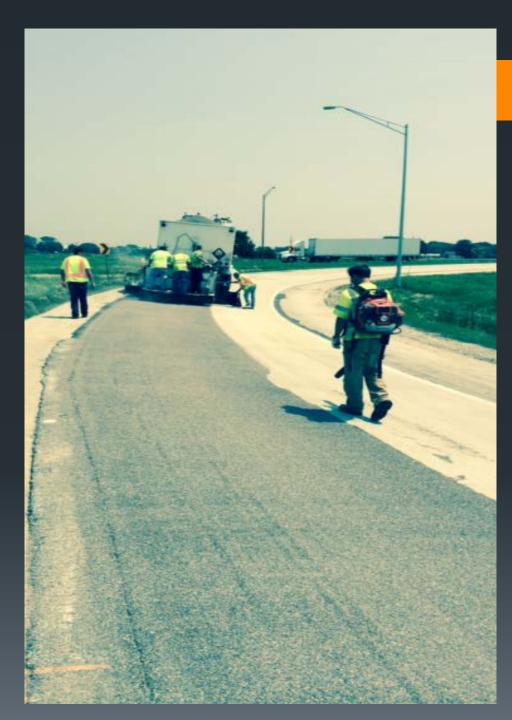
FHWA has preference for the truck method for consistency and safety.

Workers are still needed present on pavement.

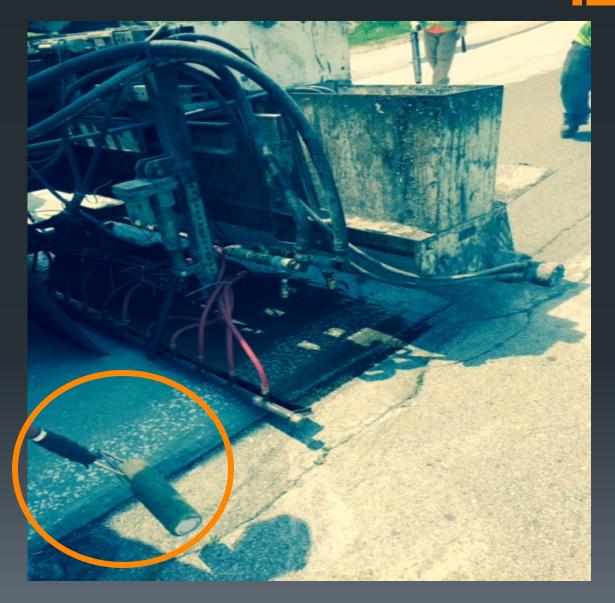
- 12ft spreader bar
- Roller to prevent air bubbles
- Blower to lay material back for 2nd pass
