IDOT District 6 Uncontrolled Crosswalk Pedestrian Safety Project

Illinois Department of Transportation

February 24, 2015

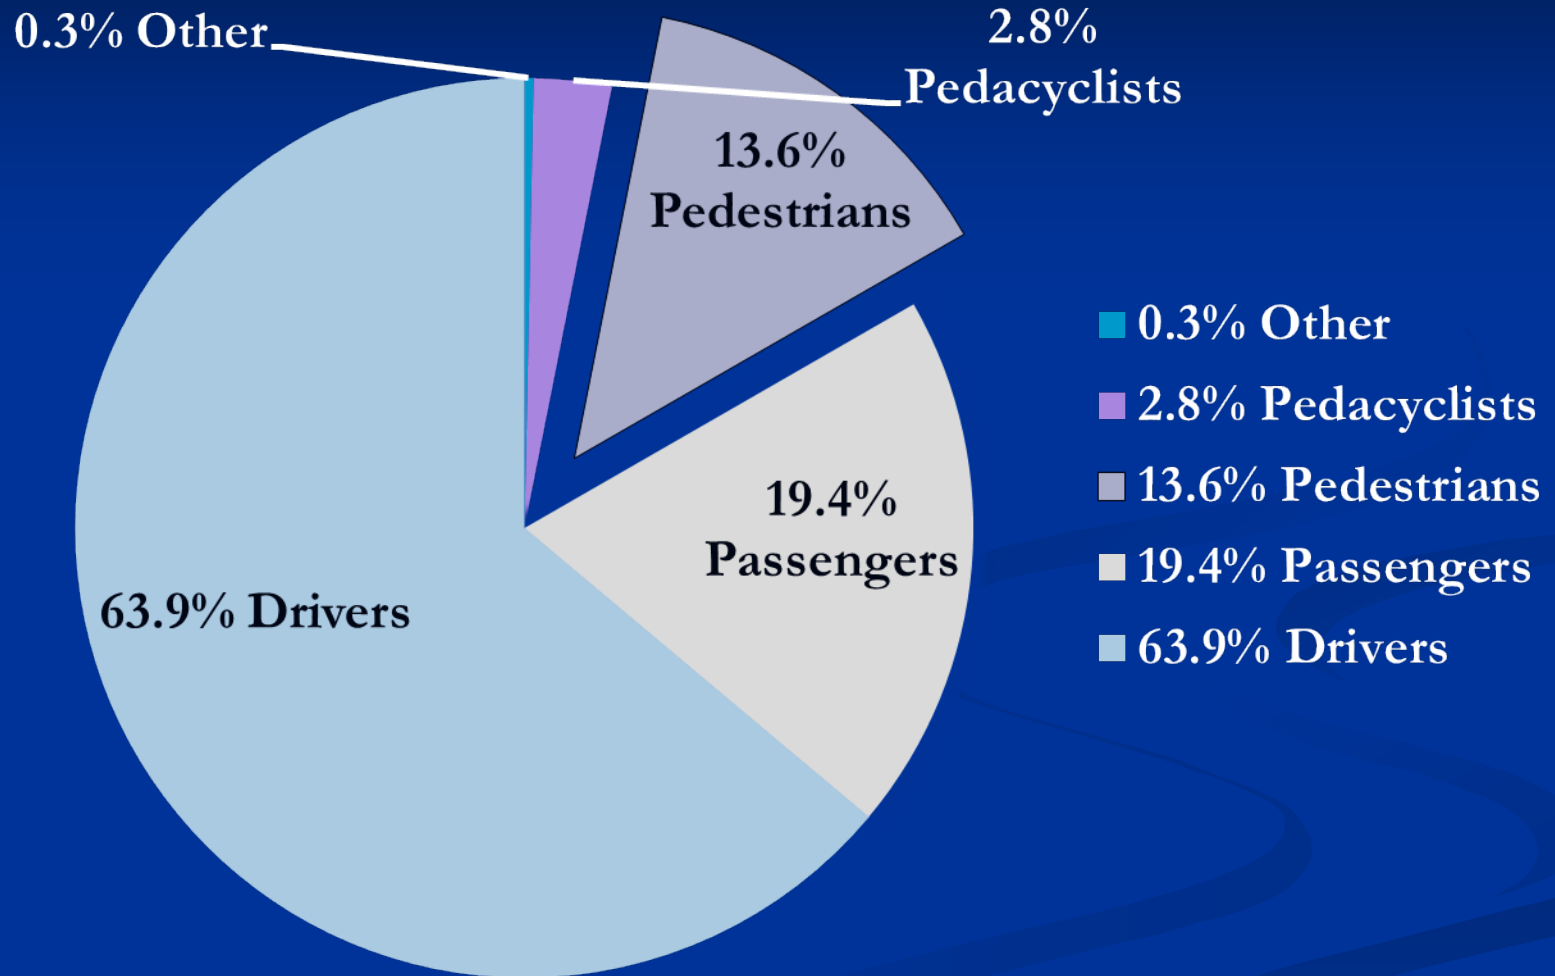
2014 Illinois Roadway Fatalities By Type

Note: "Other" includes occupants of non-motor vehicles (train passengers, occupant of horse-drawn carriage, person in building struck by motor vehicle, etc.), and equestrians.

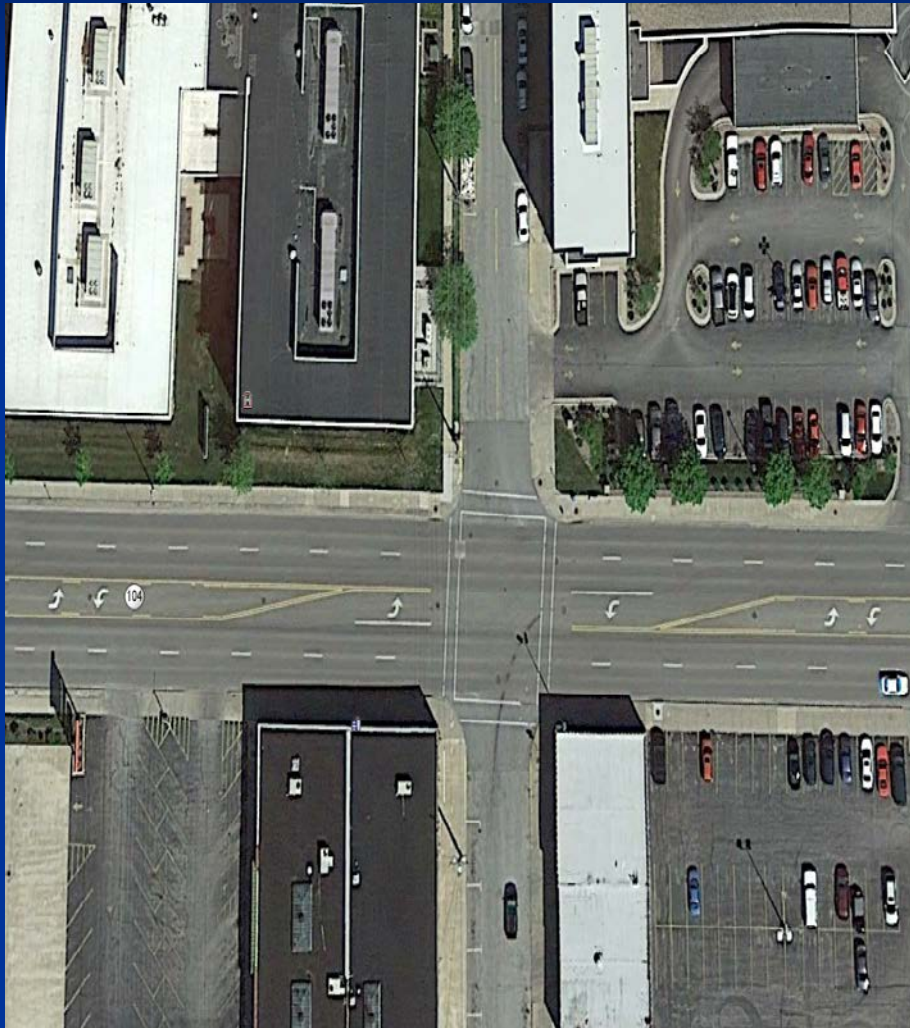
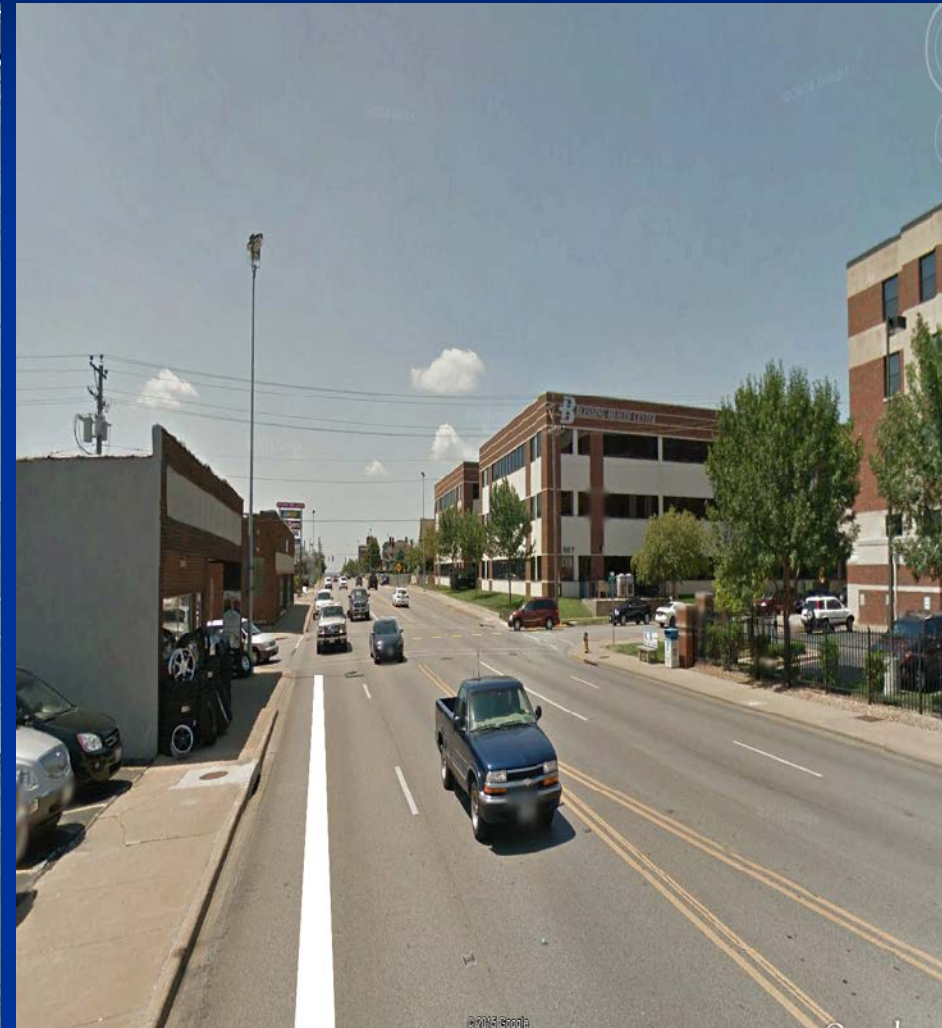
Intersection of 10th & Broadway (IL 104) in Quincy

On BSE's 2012 5% Report

IL 104 ADT = 19,000

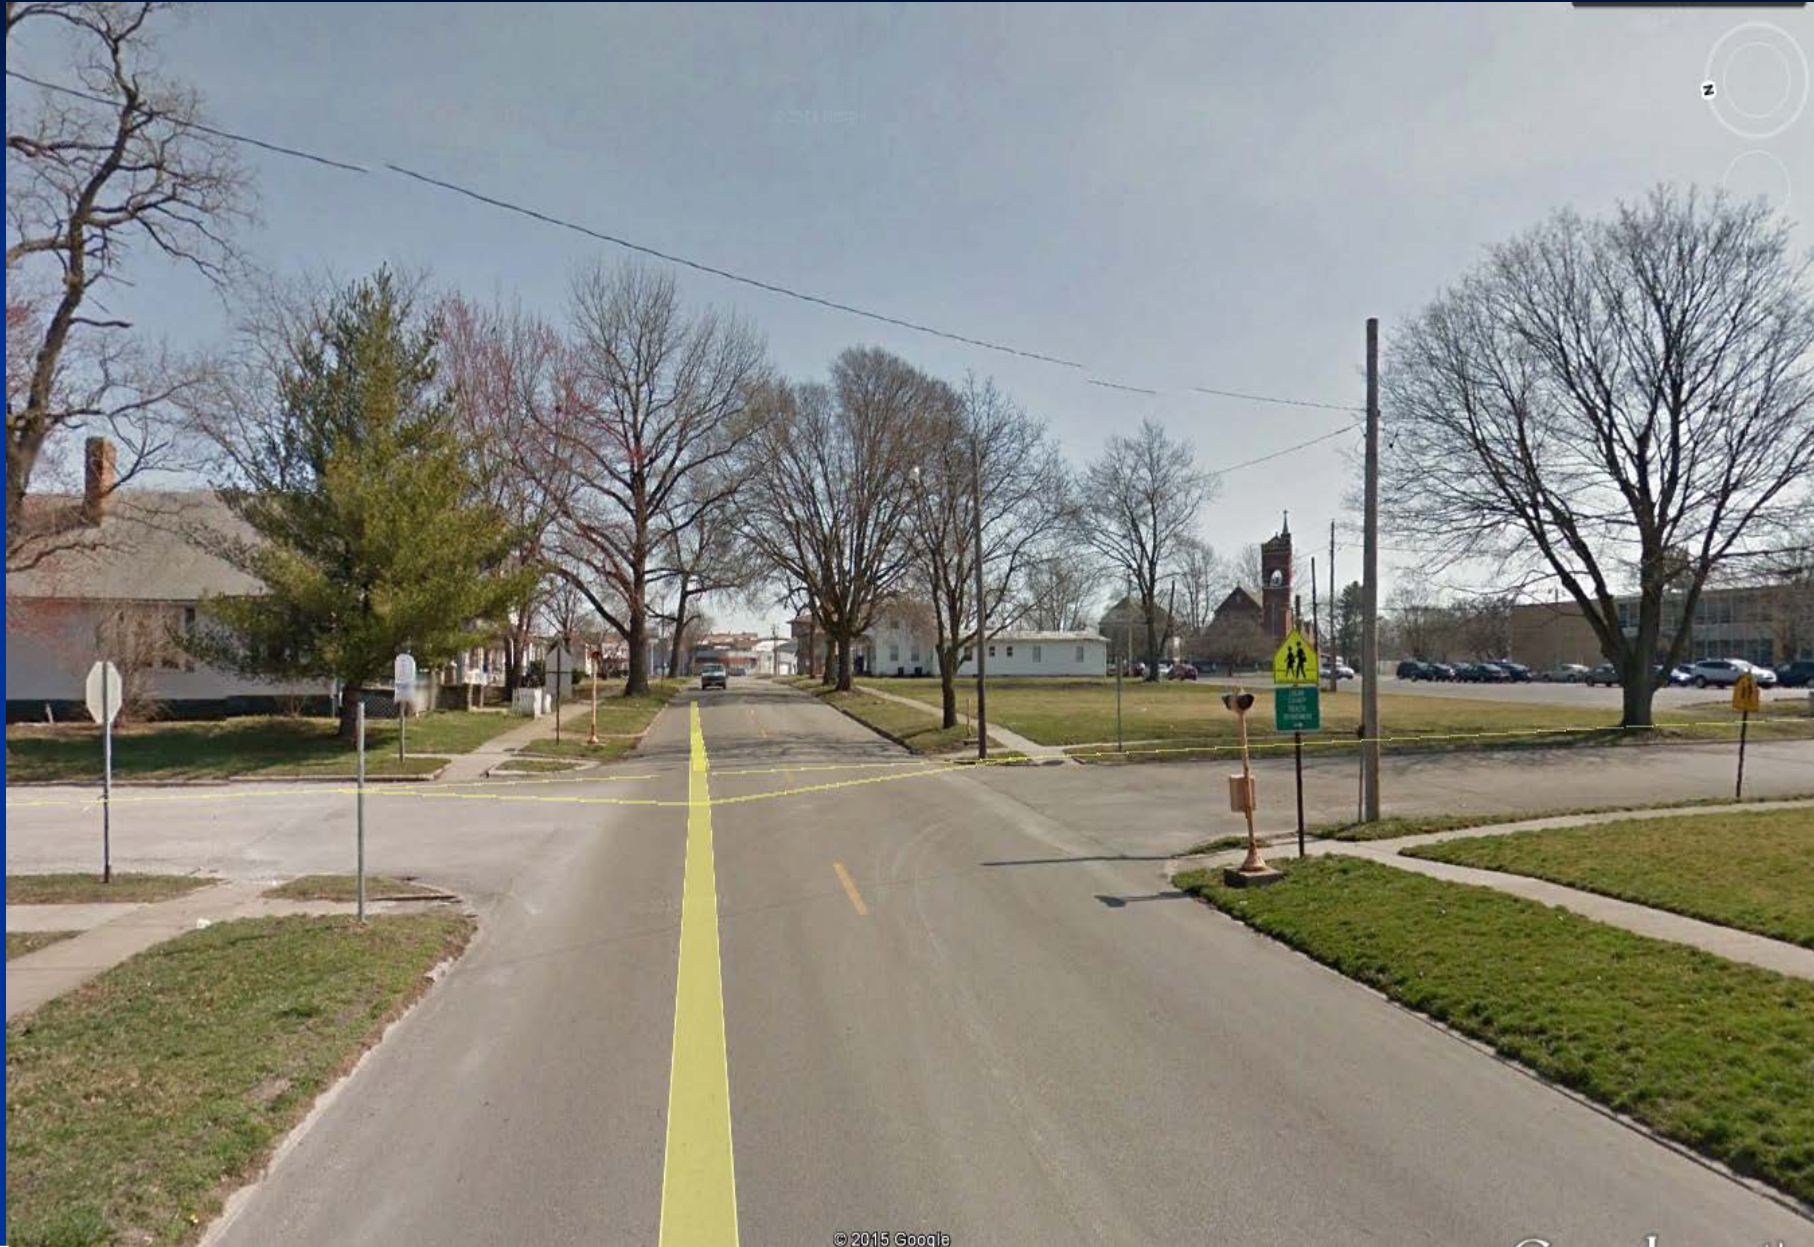
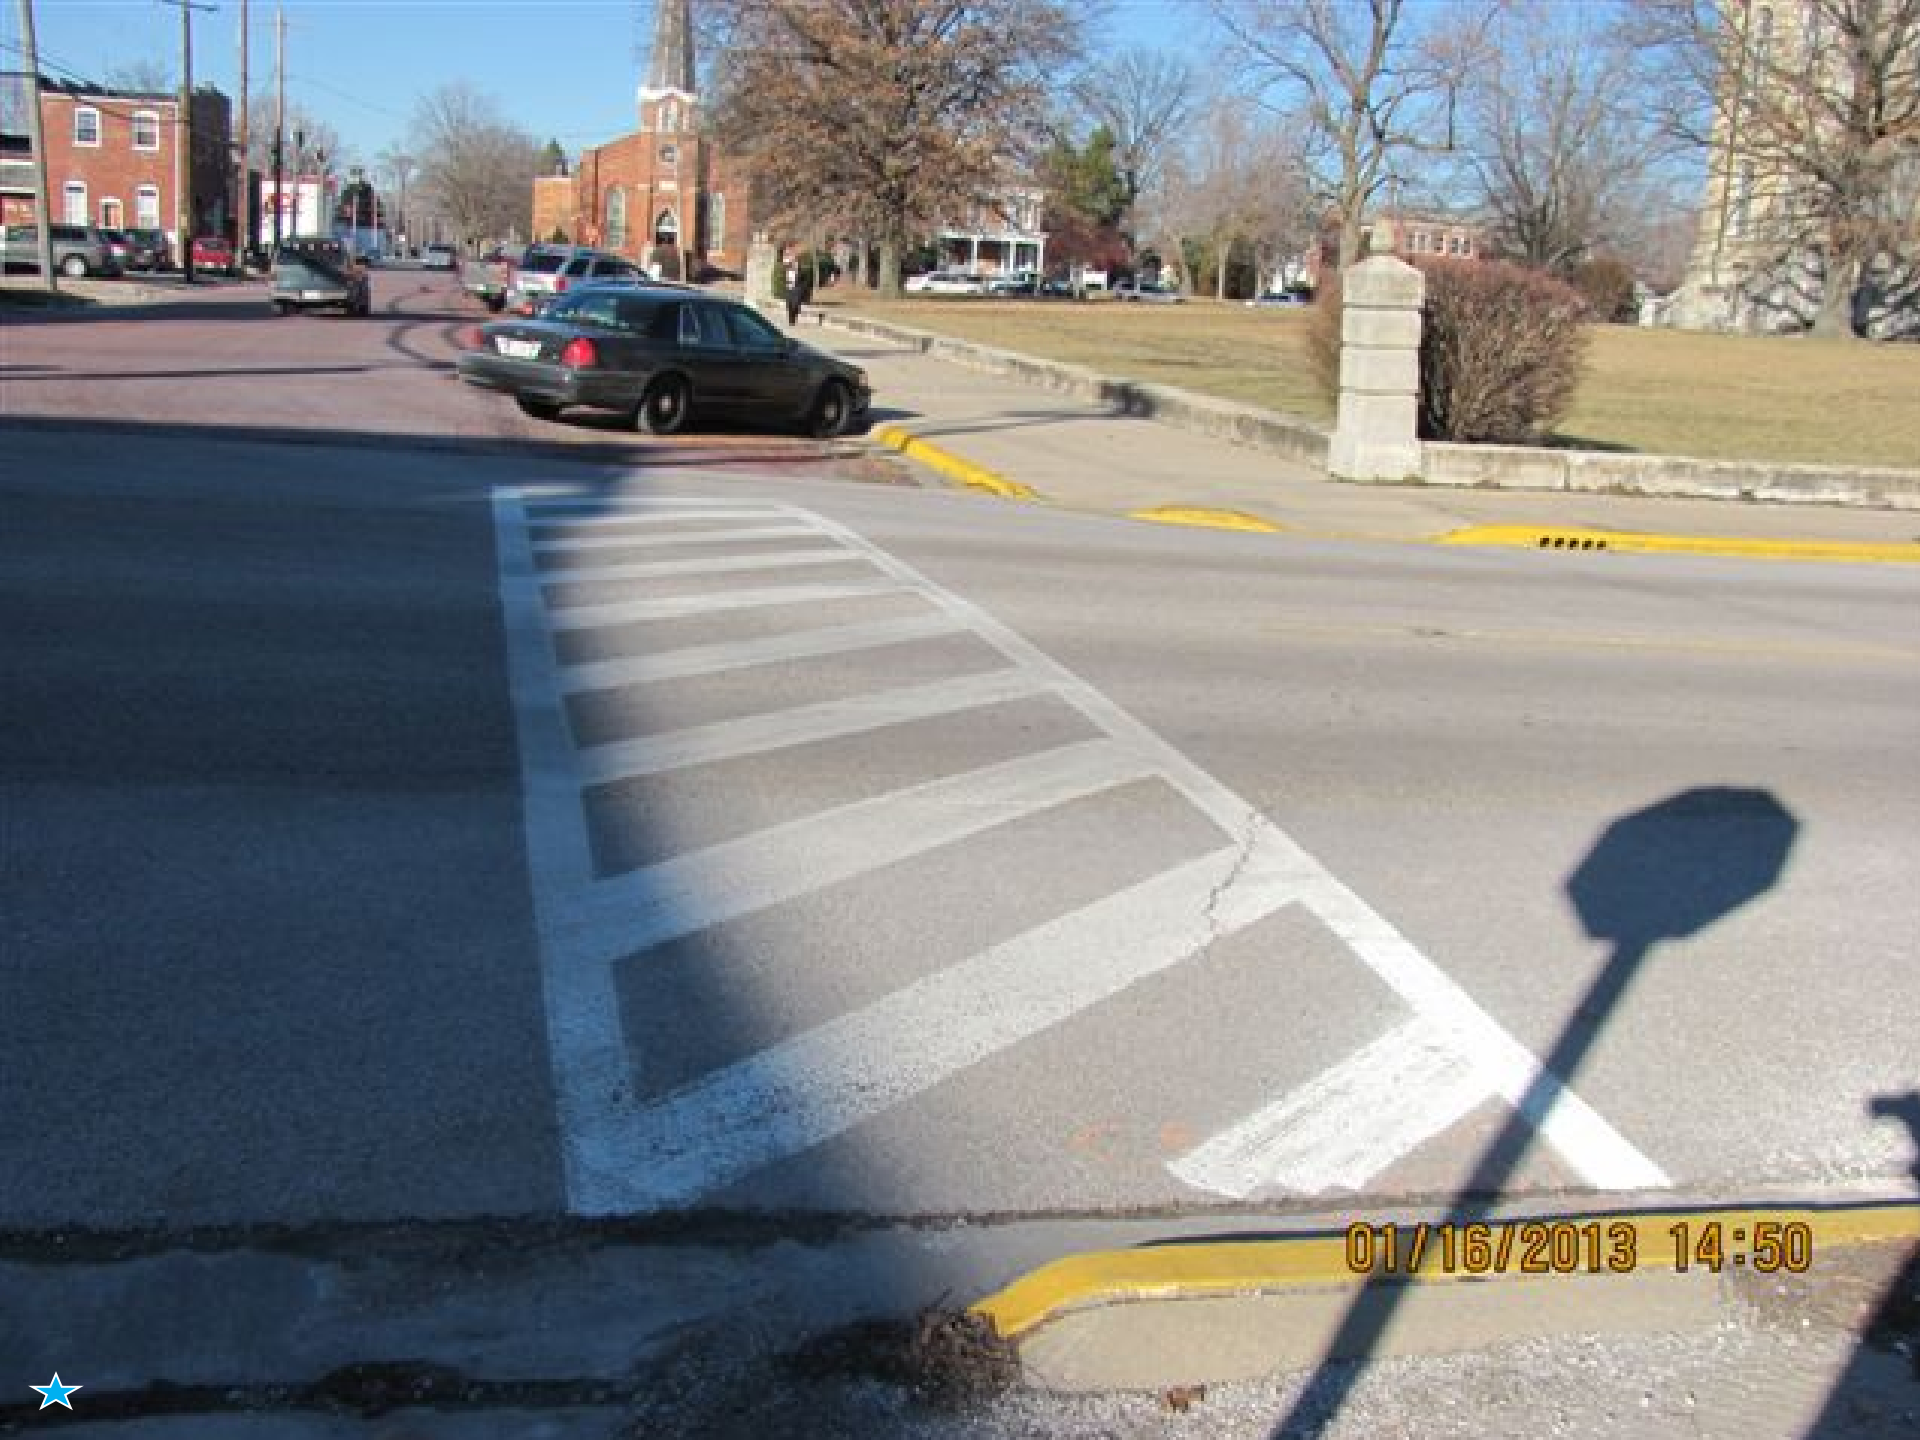
- It's Hard to Guide Pedestrians to Set Crossing Locations
- Inconsistent Applications
 - Lack of Advanced Warning Signs
 - Lack of Crosswalk Visibility
 - Underuse/Overuse of Crosswalk Striping
- Visual “Clutter”
- Antiquated Traffic Control Devices
- Non-Permitted Treatments

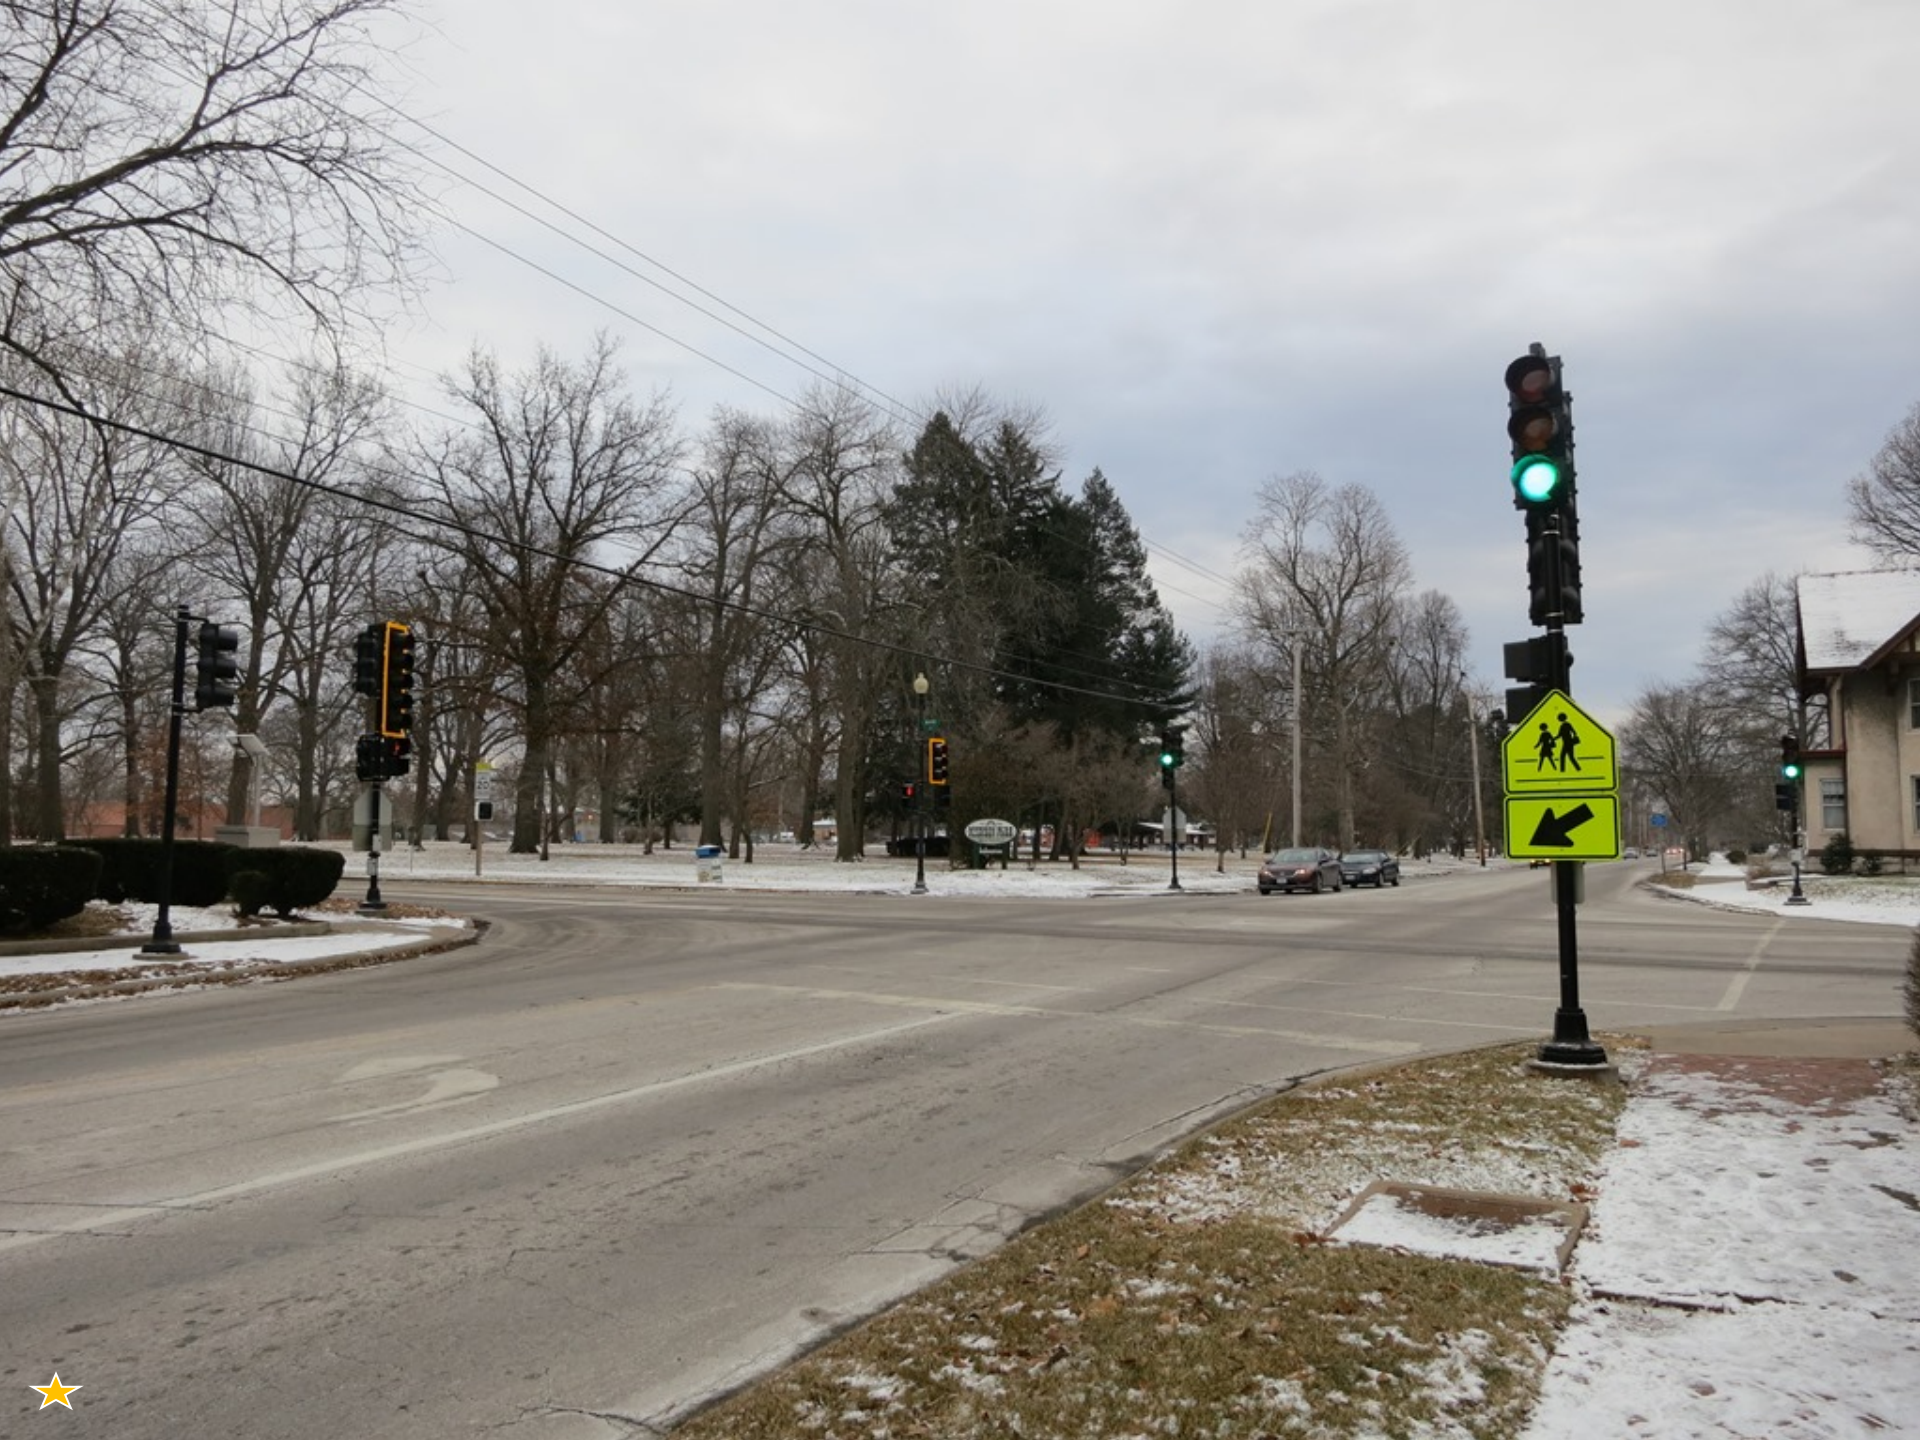
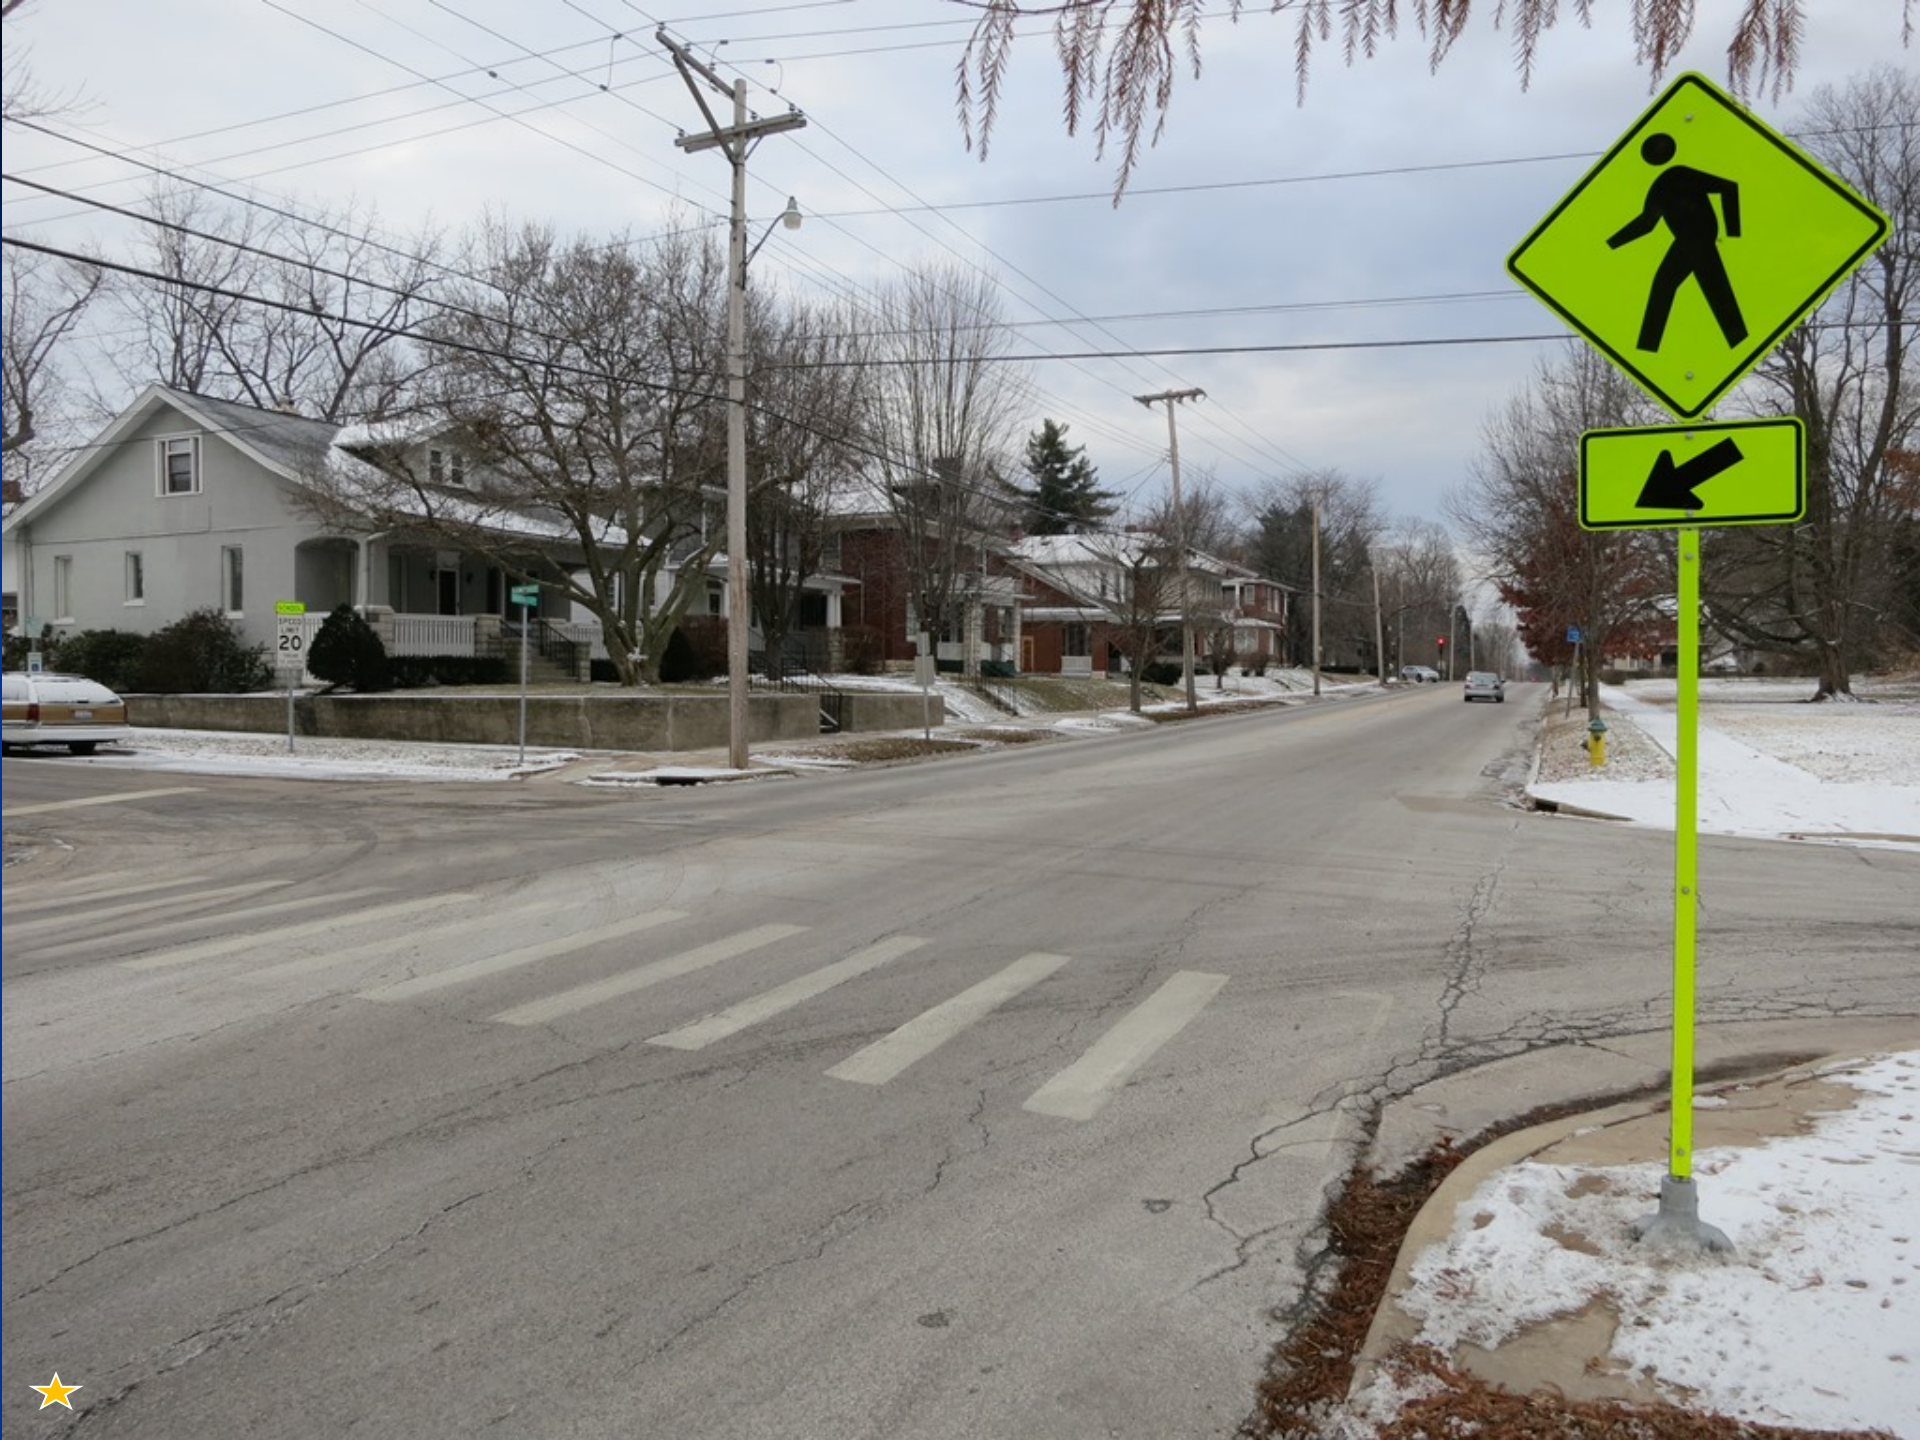
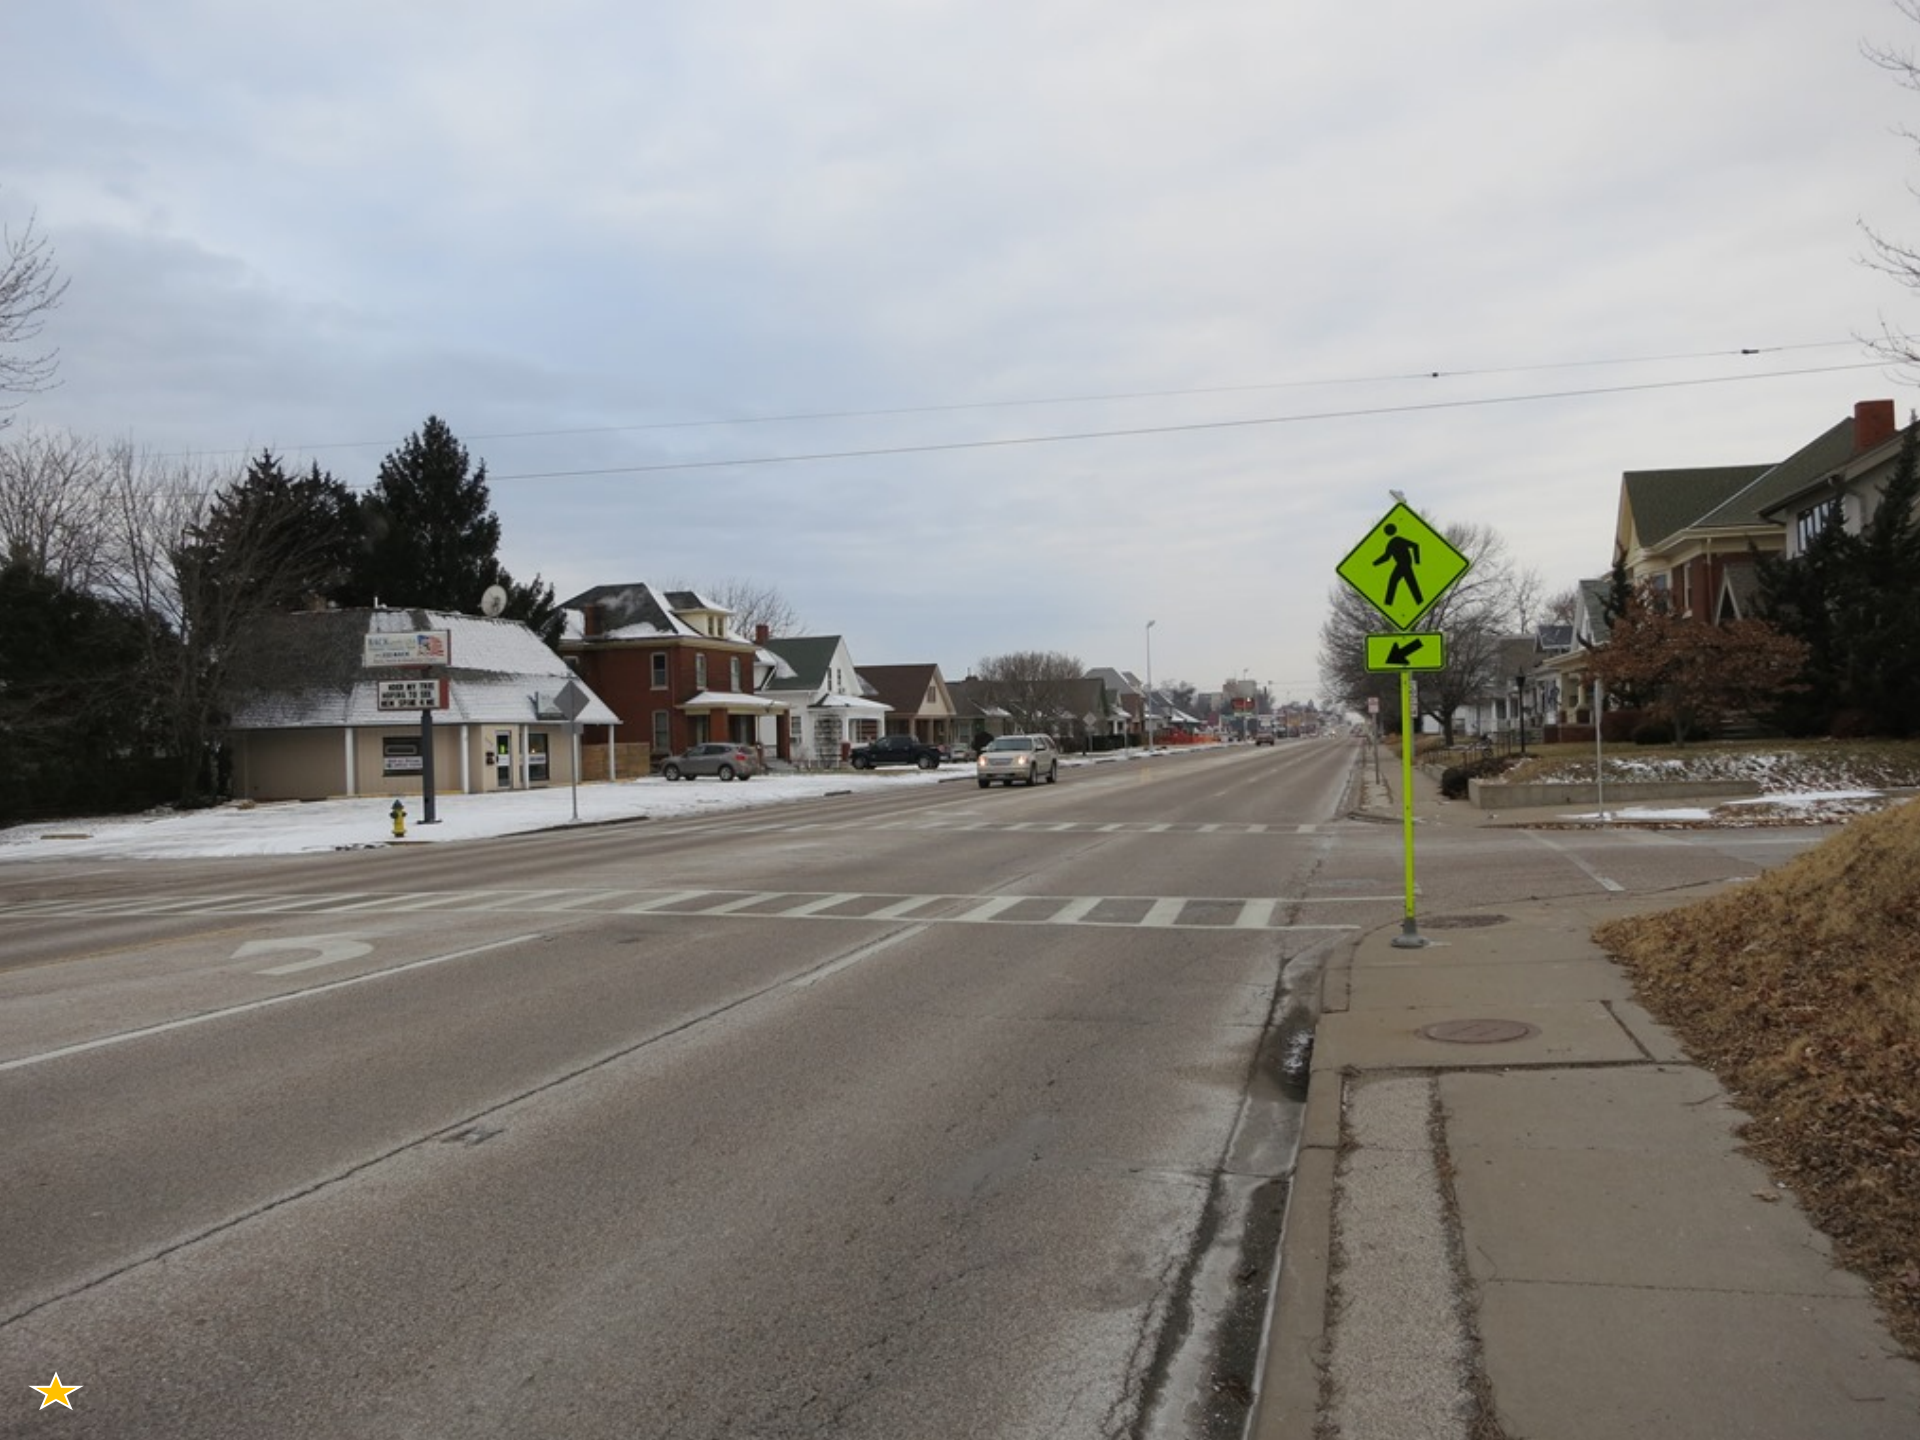
Continental Markings

- “Ladder” style continental marking uses 3 times the material as a “two lines” marking.
- Additional conspicuity worth the extra cost.

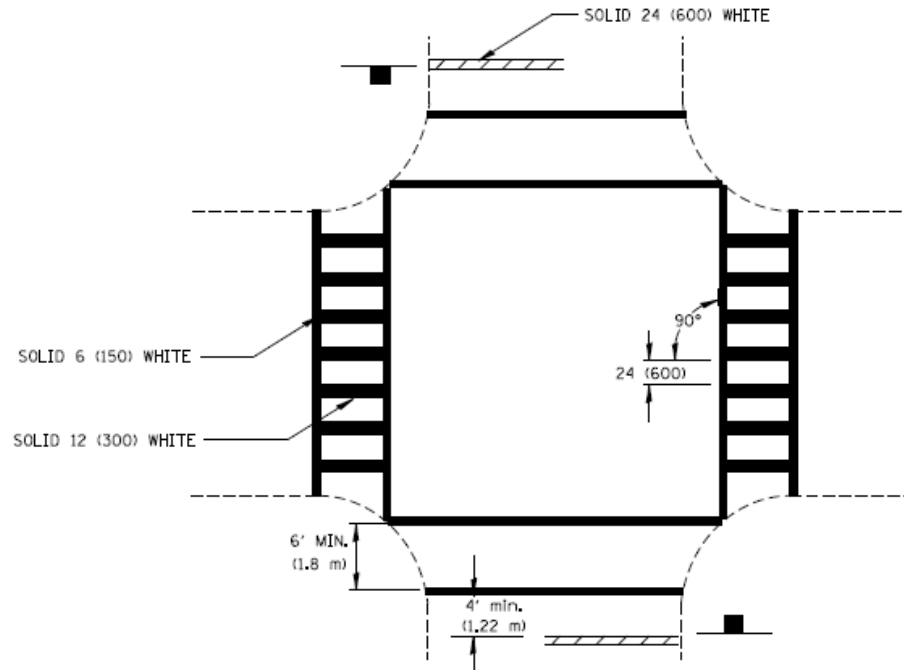
NON-SIGNALIZED INTERSECTION
OR
MID-BLOCK CROSSING

CROSSWALK MARKINGS SHOULD NOT BE USED INDISCRIMINATELY. AN ENGINEERING STUDY IS REQUIRED BEFORE THEY ARE INSTALLED AT LOCATIONS AWAY FROM TRAFFIC SIGNALS OR STOP SIGNS.
CROSSWALK SHALL CONNECT TO CURB CUTS OR SIDEWALKS. CROSSWALKS MAY BE INSTALLED AT A SKEW TO PERMIT THIS CONNECTION.

HMA SURFACES USE: URBAN THERMOPLASTIC
RURAL - CALL OPERATIONS
CONCRETE SURFACES USE: EPOXY

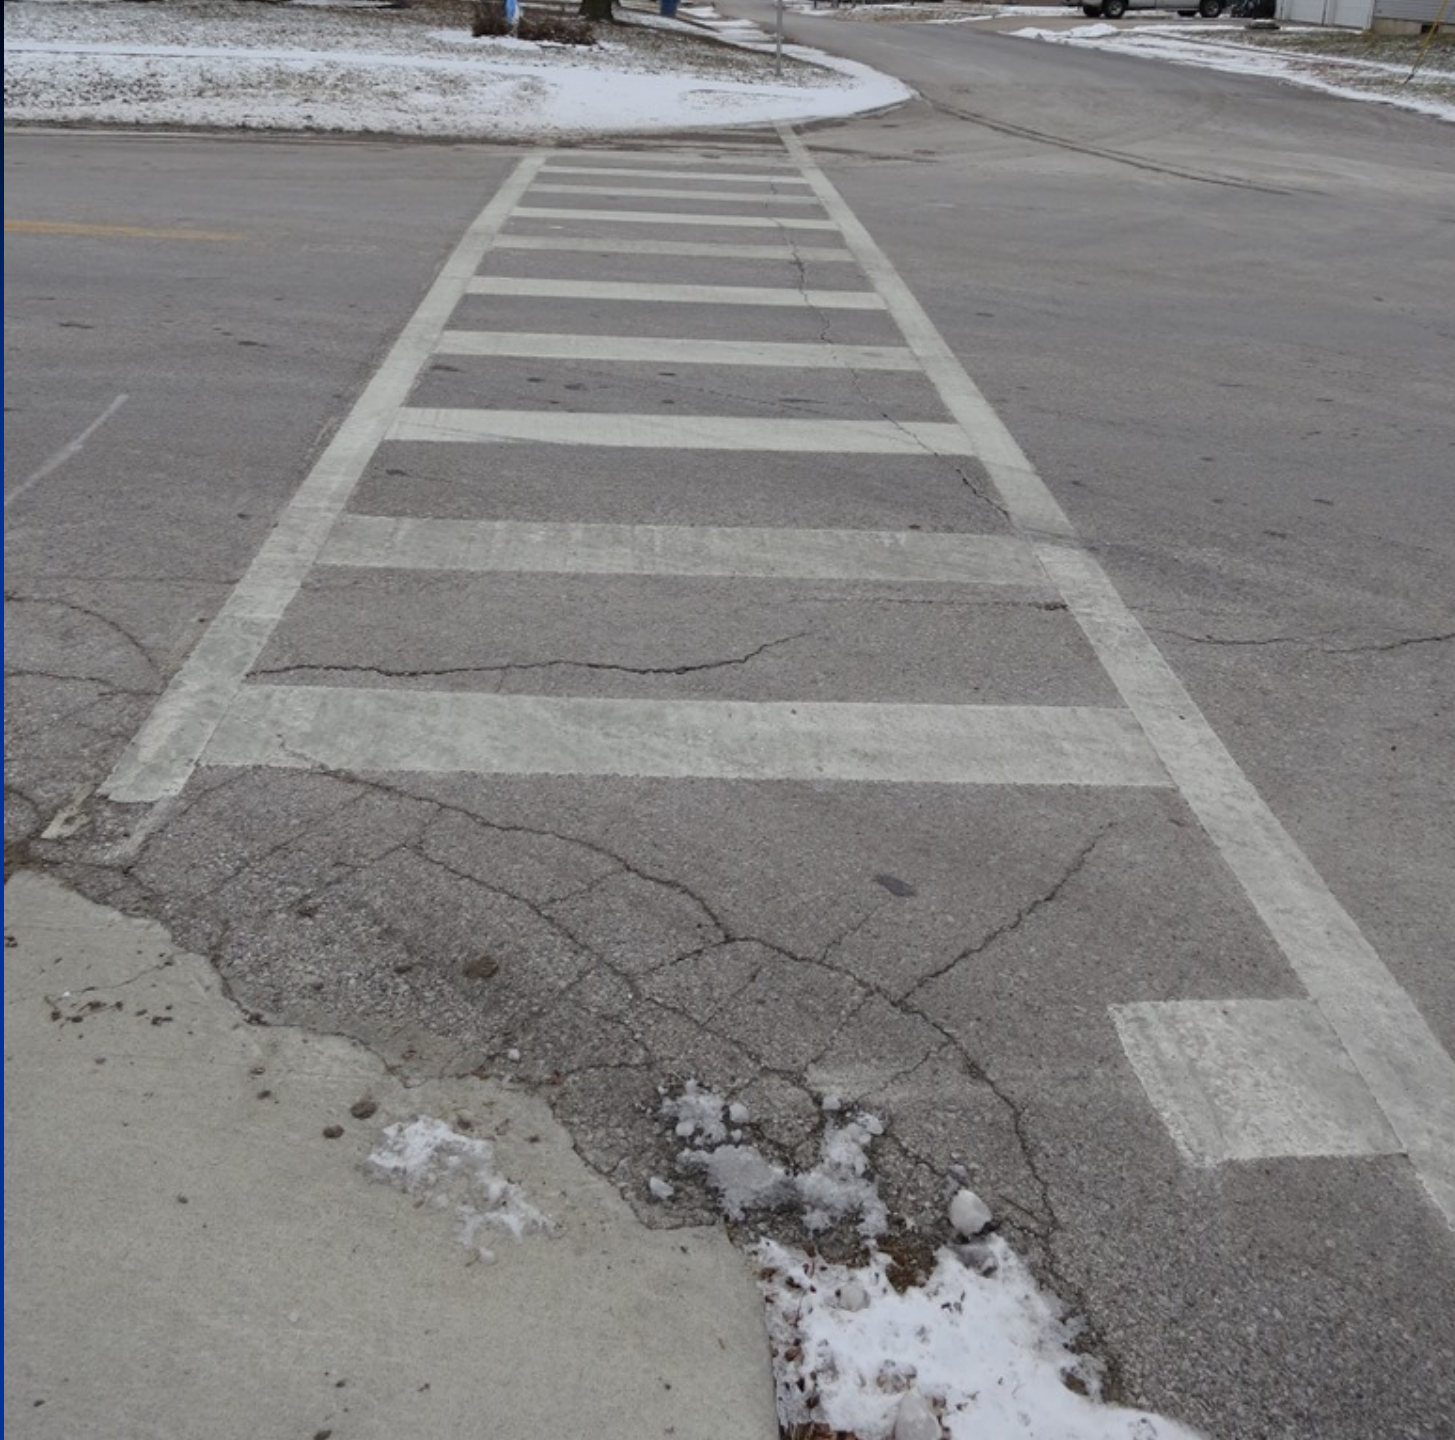
- Contract price 72G76
 - Mobilization - lump sum
 - \$2.40 per foot, 12 inch line
 - A 50 ft wide crossing = 150 sq ft = \$360

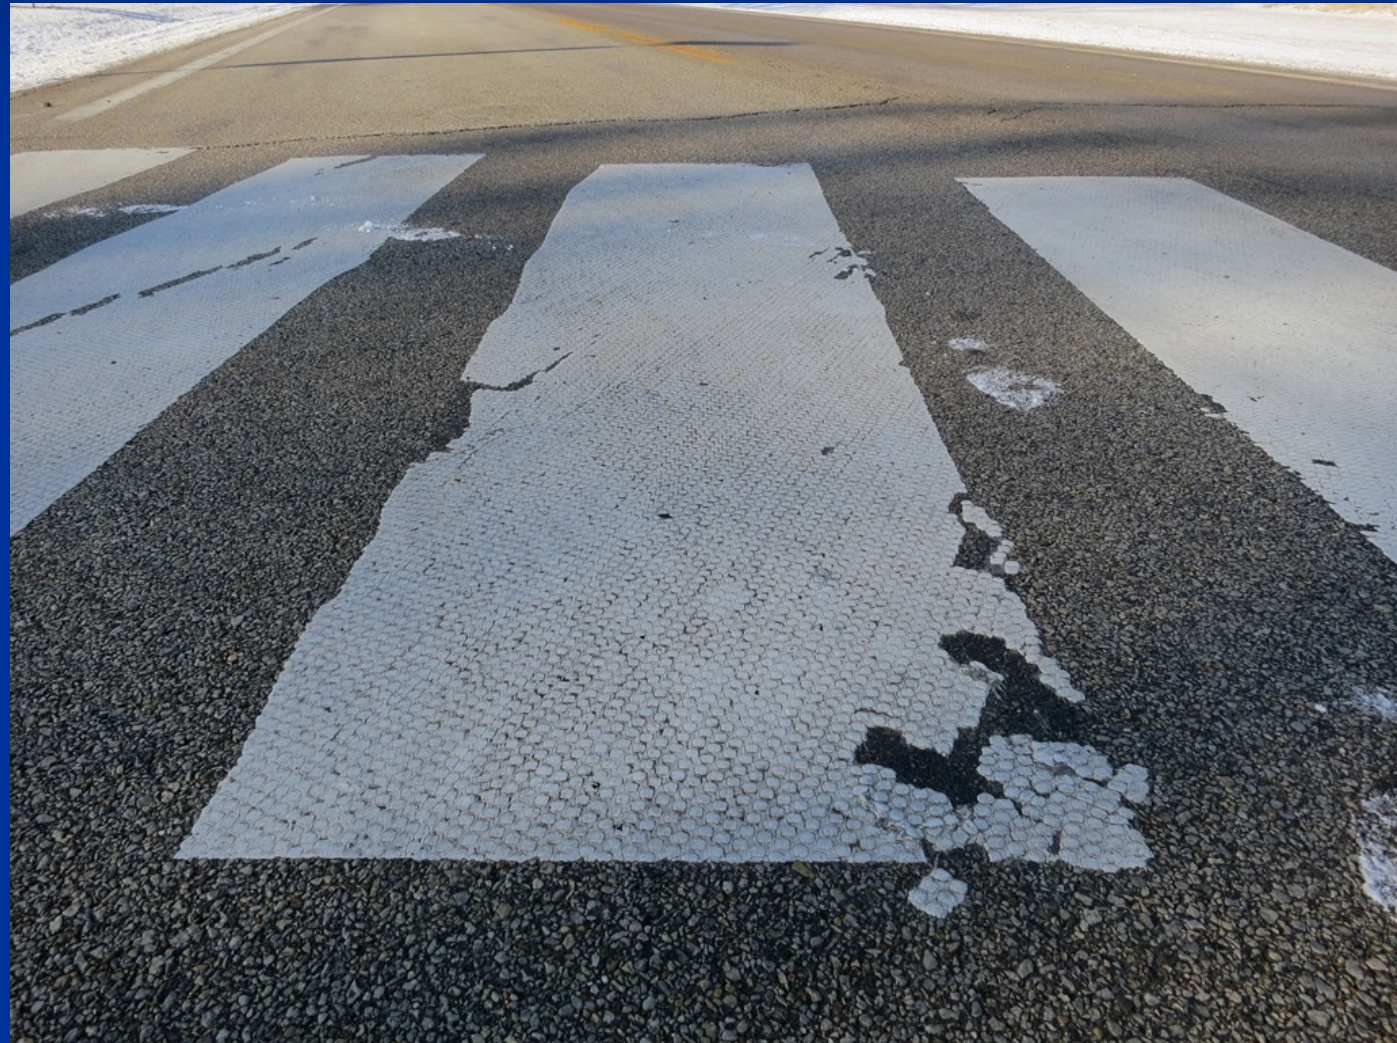
- Why not preformed?
 - Retrofit application
