IDOT District 6 Uncontrolled Crosswalk Pedestrian Safety Project

Illinois Department of Transportation

February 24, 2015

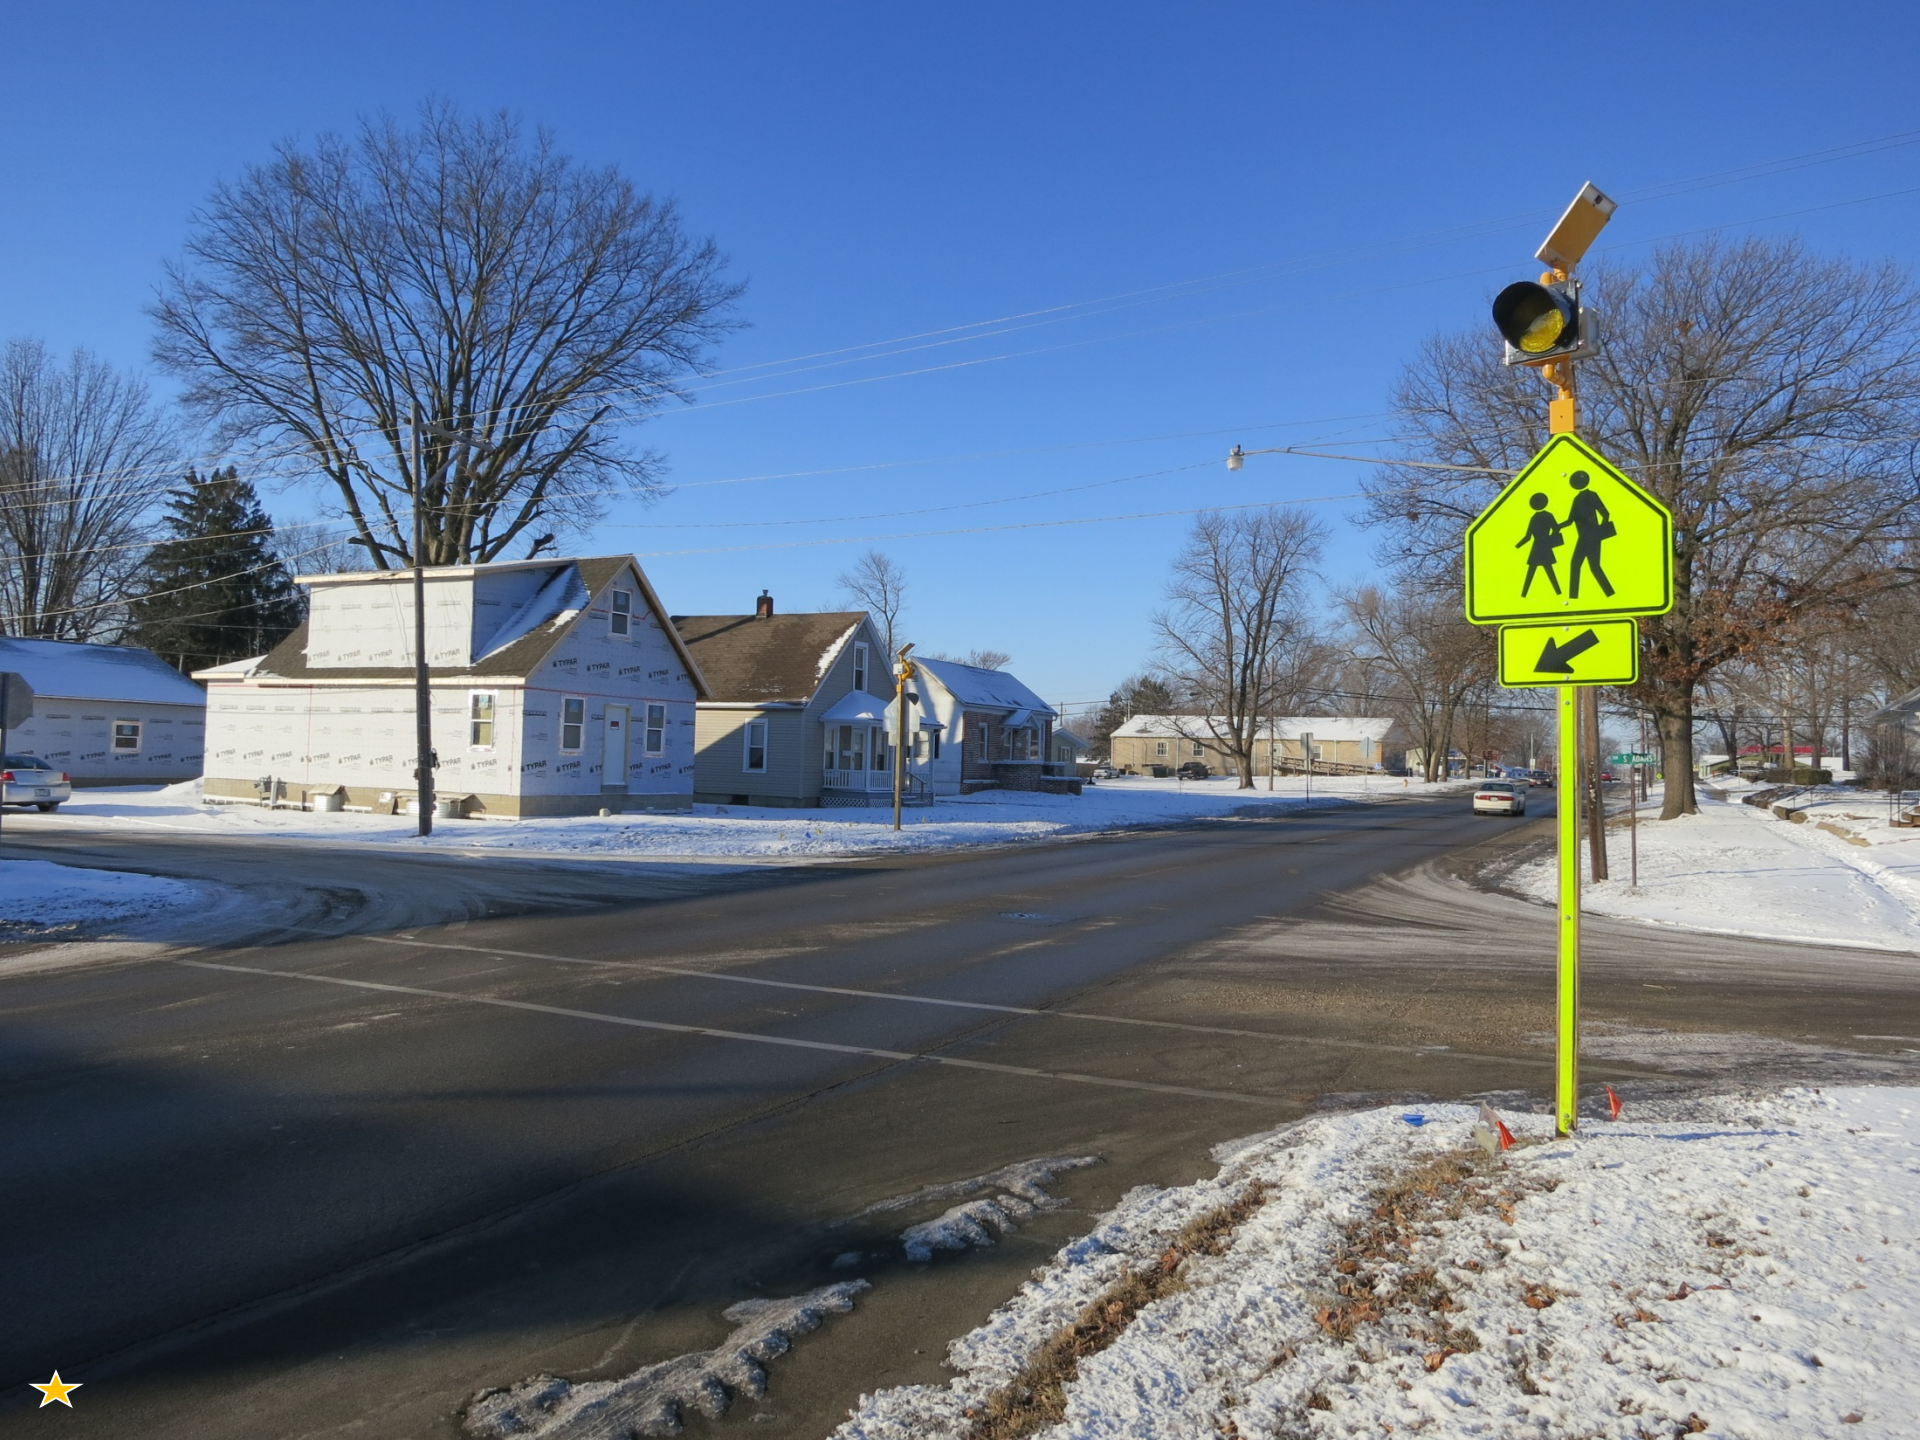
- Removed old “Pelican” style beacons
- Installed new solar beacons
- Contract 72G76
 - Removal of existing beacons and time switch equipment - \$630 each
 - Beacons –
 - \$4480 to furnish and install beacons
 - \$950 for digital time switch
 - \$5430 total per beacon

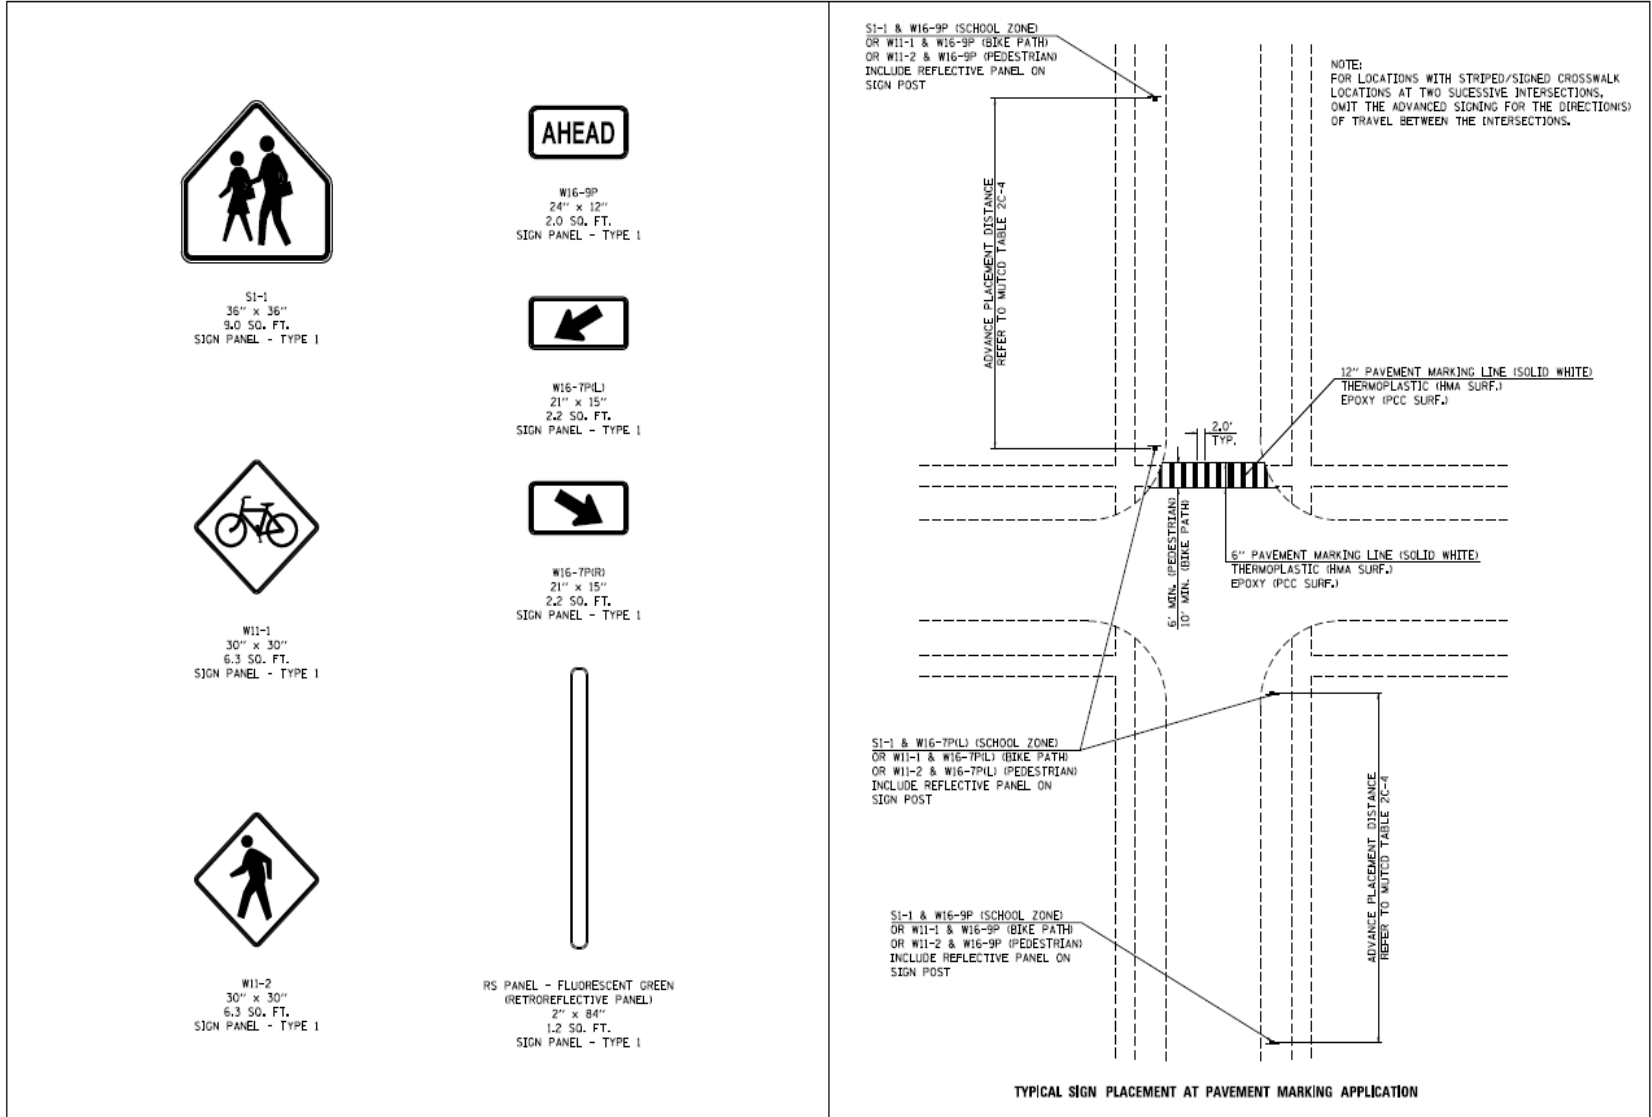
SIGN AND PAVEMENT MARKING DETAILS

■ Signing & Striping Upgrades at 140 Locations

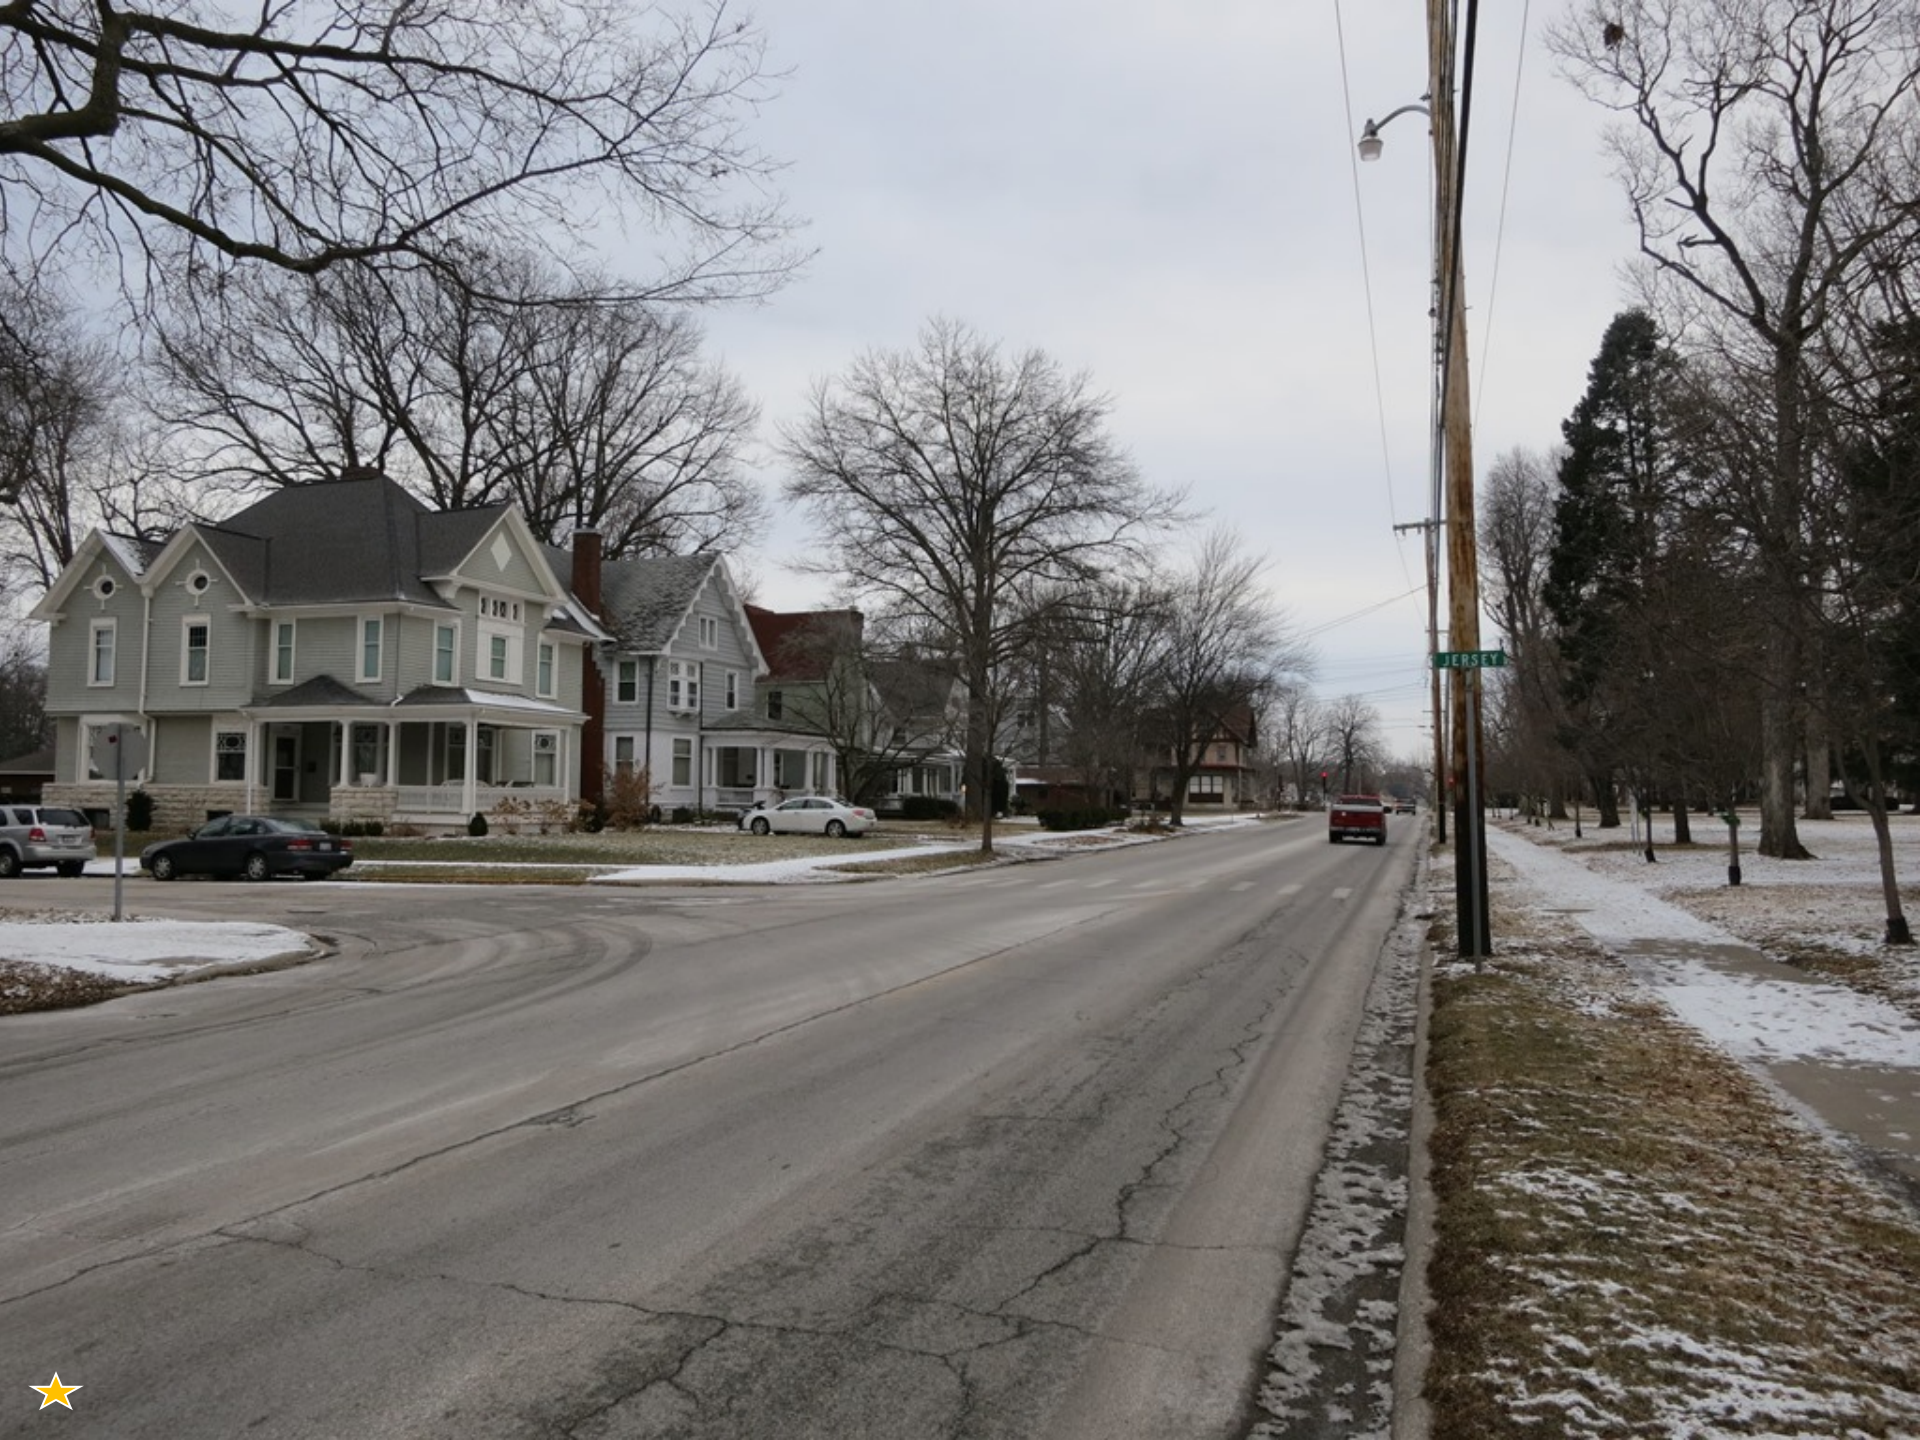
Problems on 24th Street in Quincy

- Installed new signs, with markings to follow
- City police called – did not want south uncontrolled location.

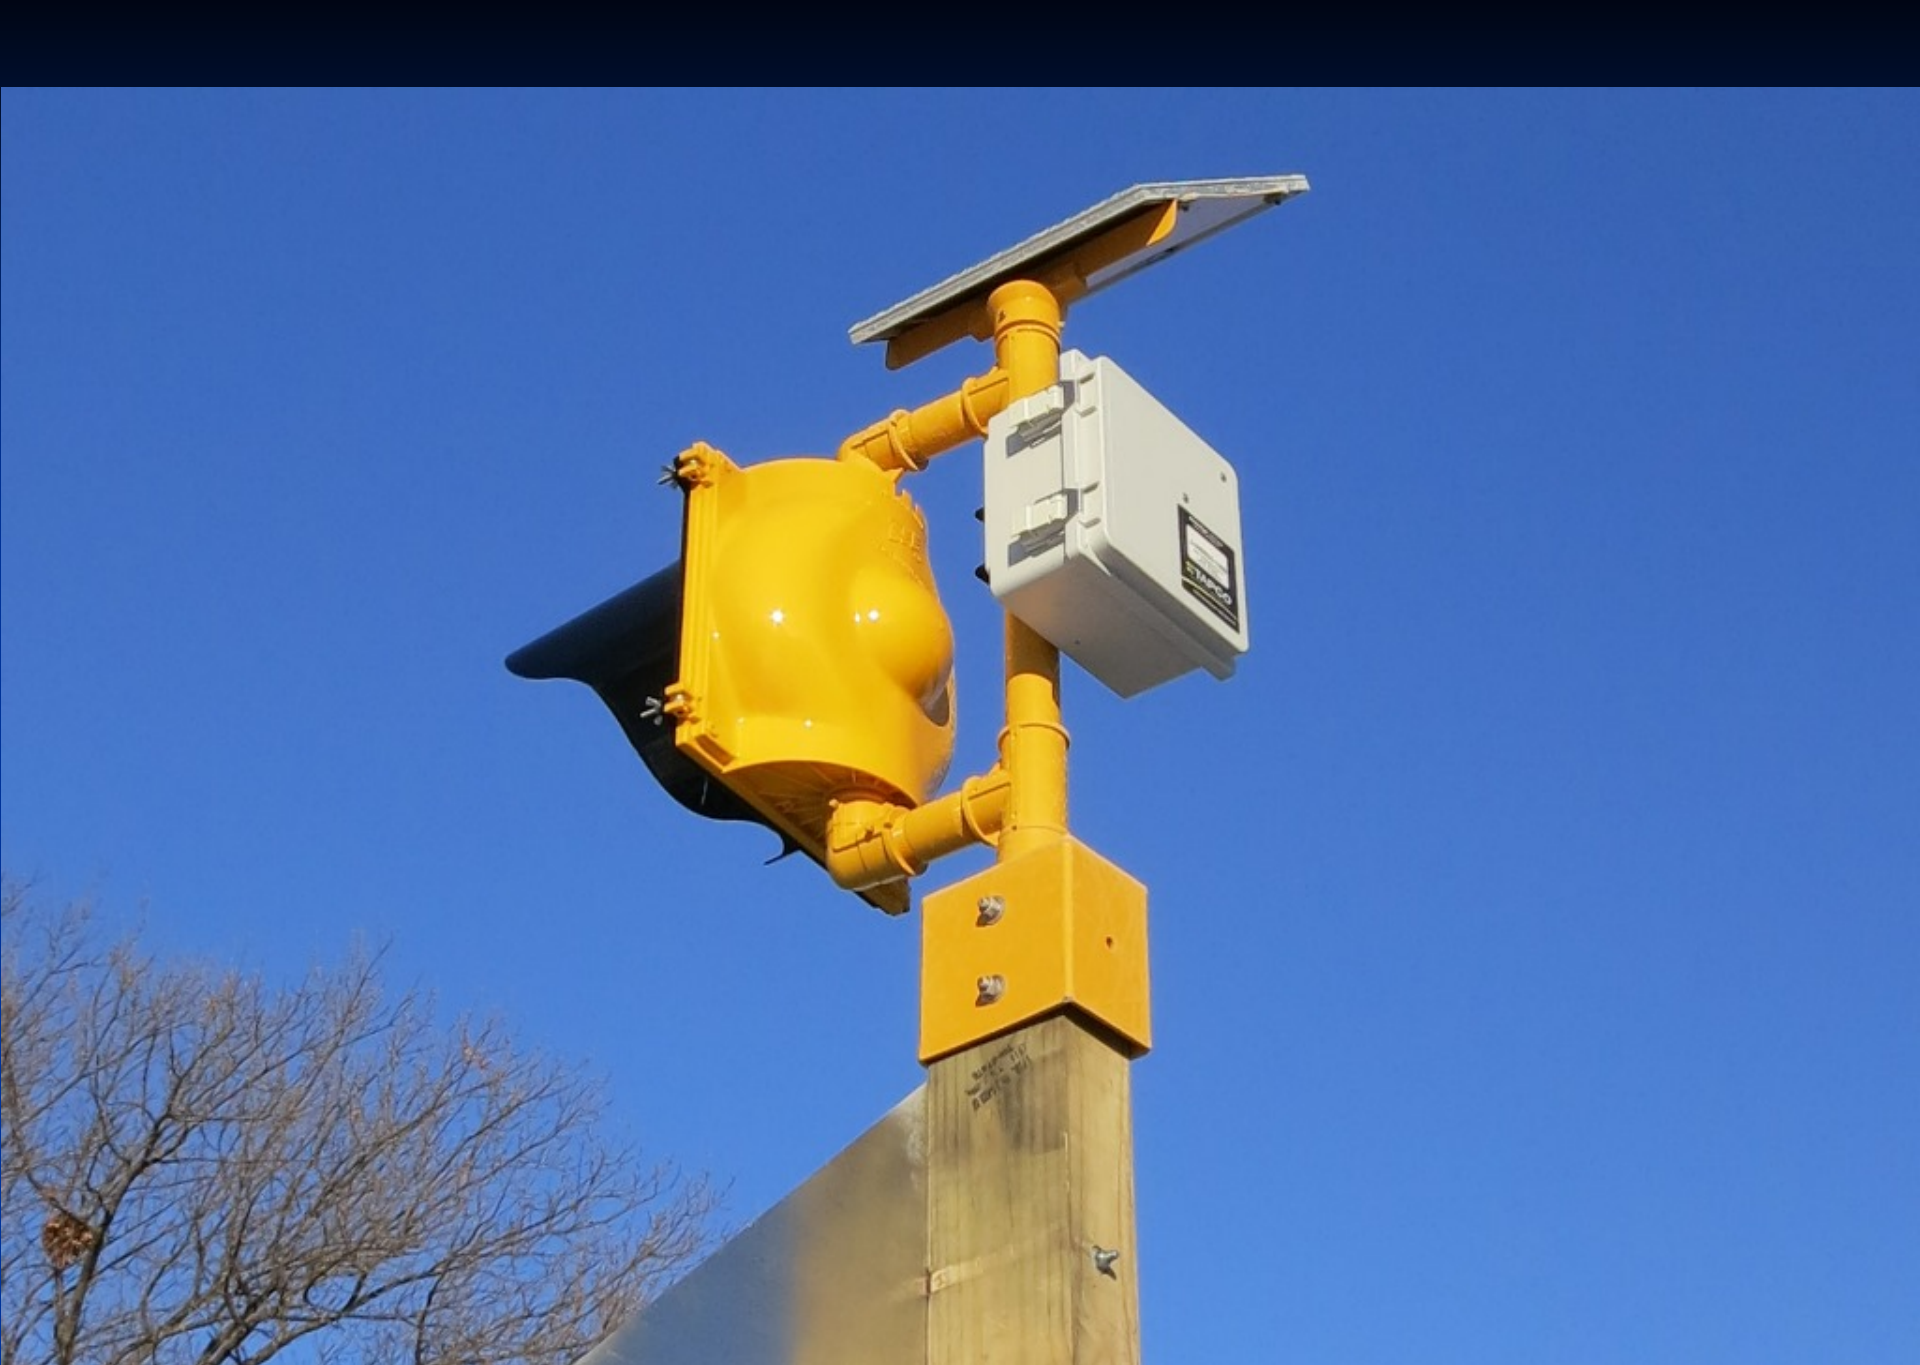
Beacon Problems

- Digital Time Switch Specification Interpretation
- Bad Aim
- Communication Breakdown
- Does anybody know what time it is?

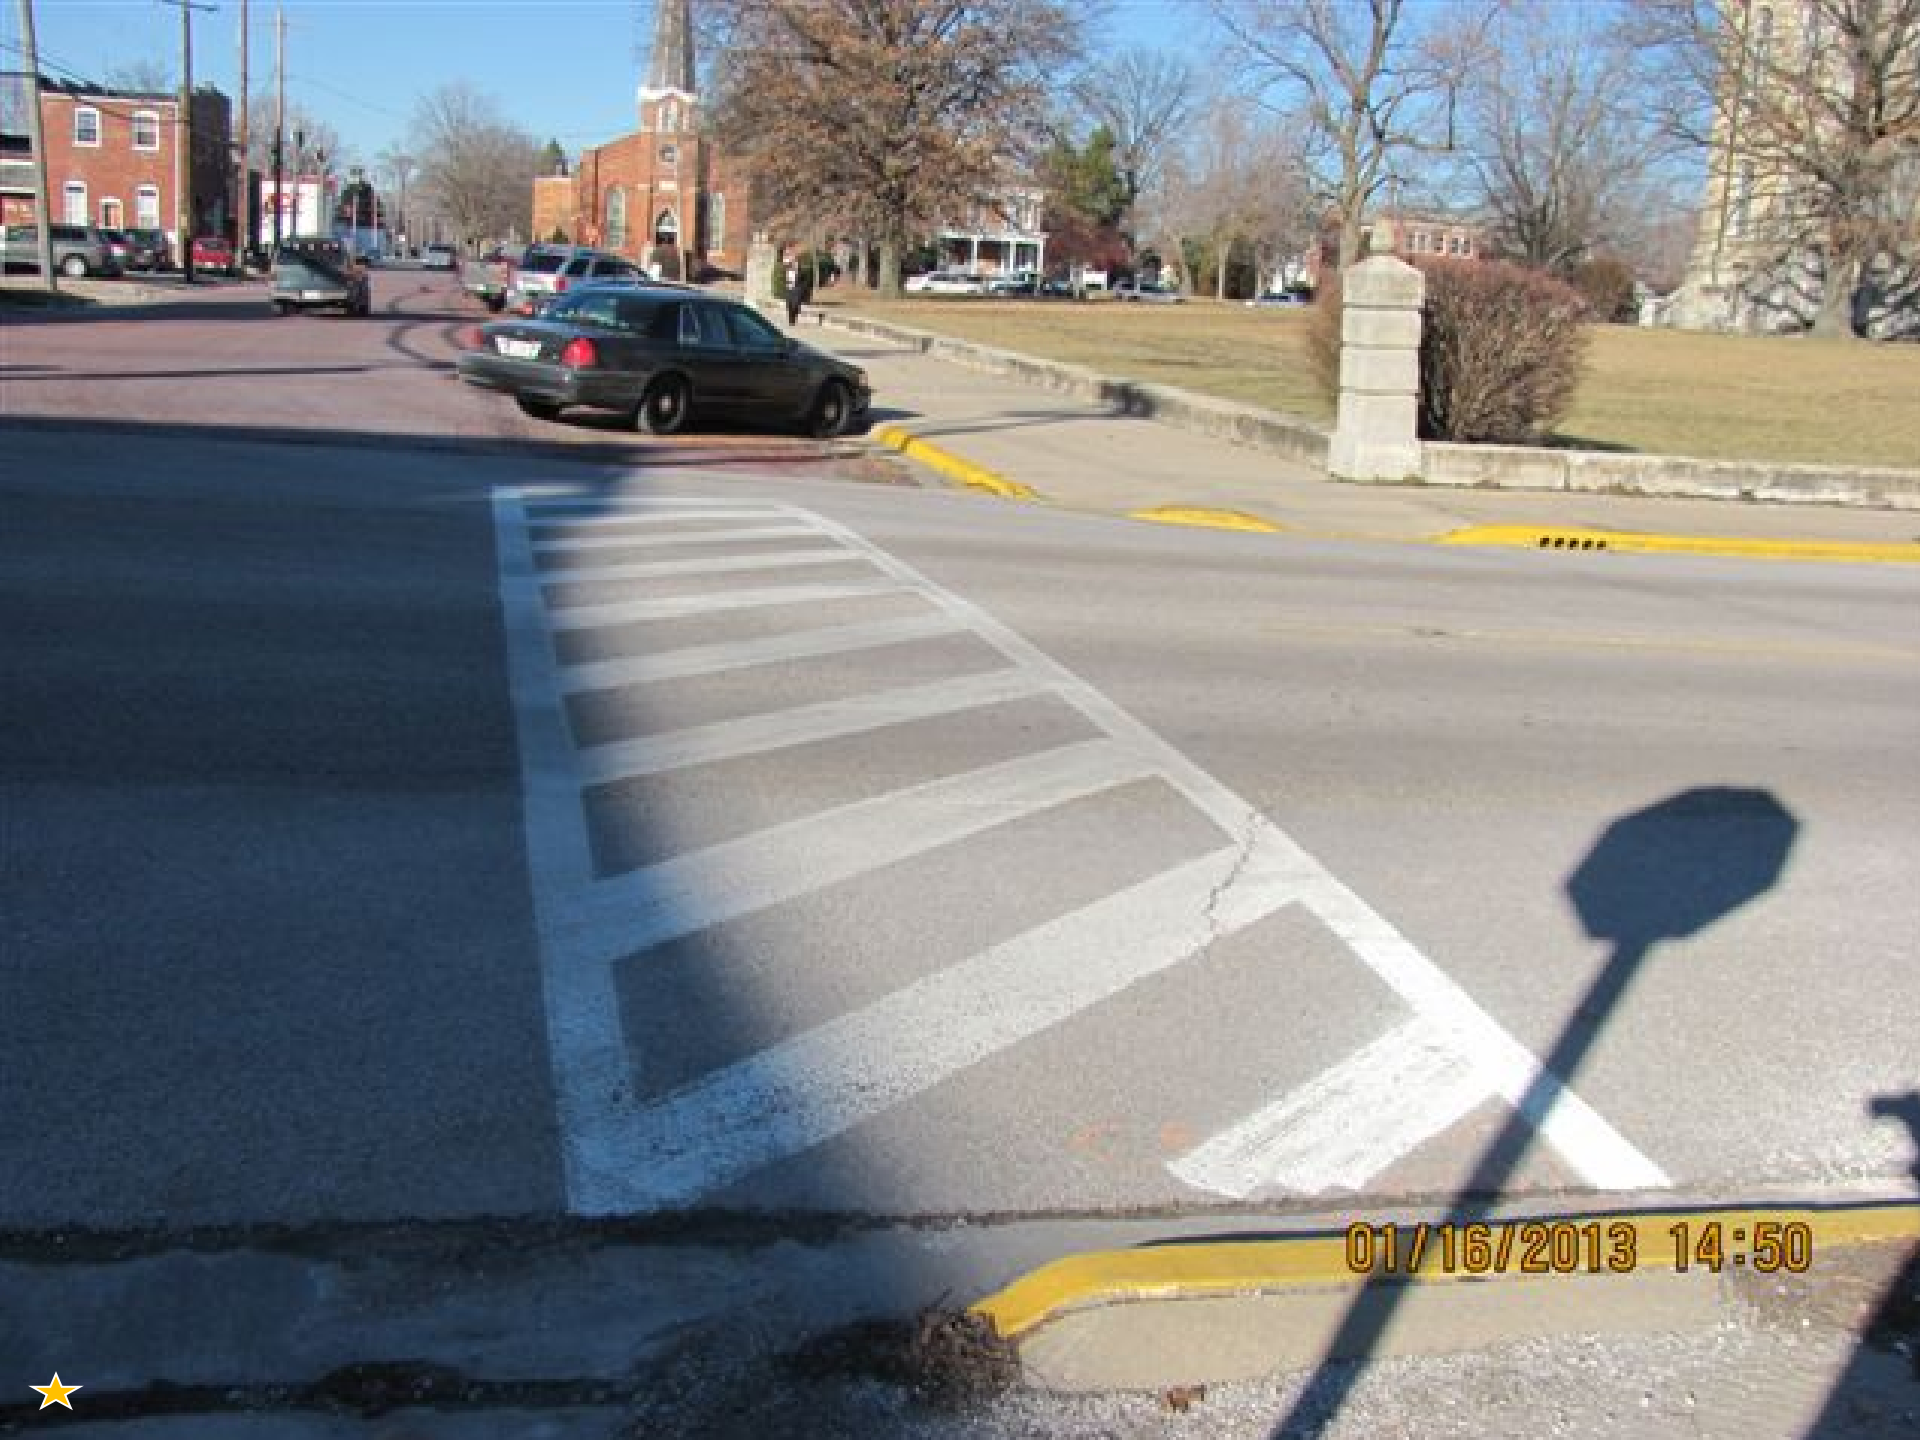
- Construction Inspector misunderstood intent of crosswalk/District typical

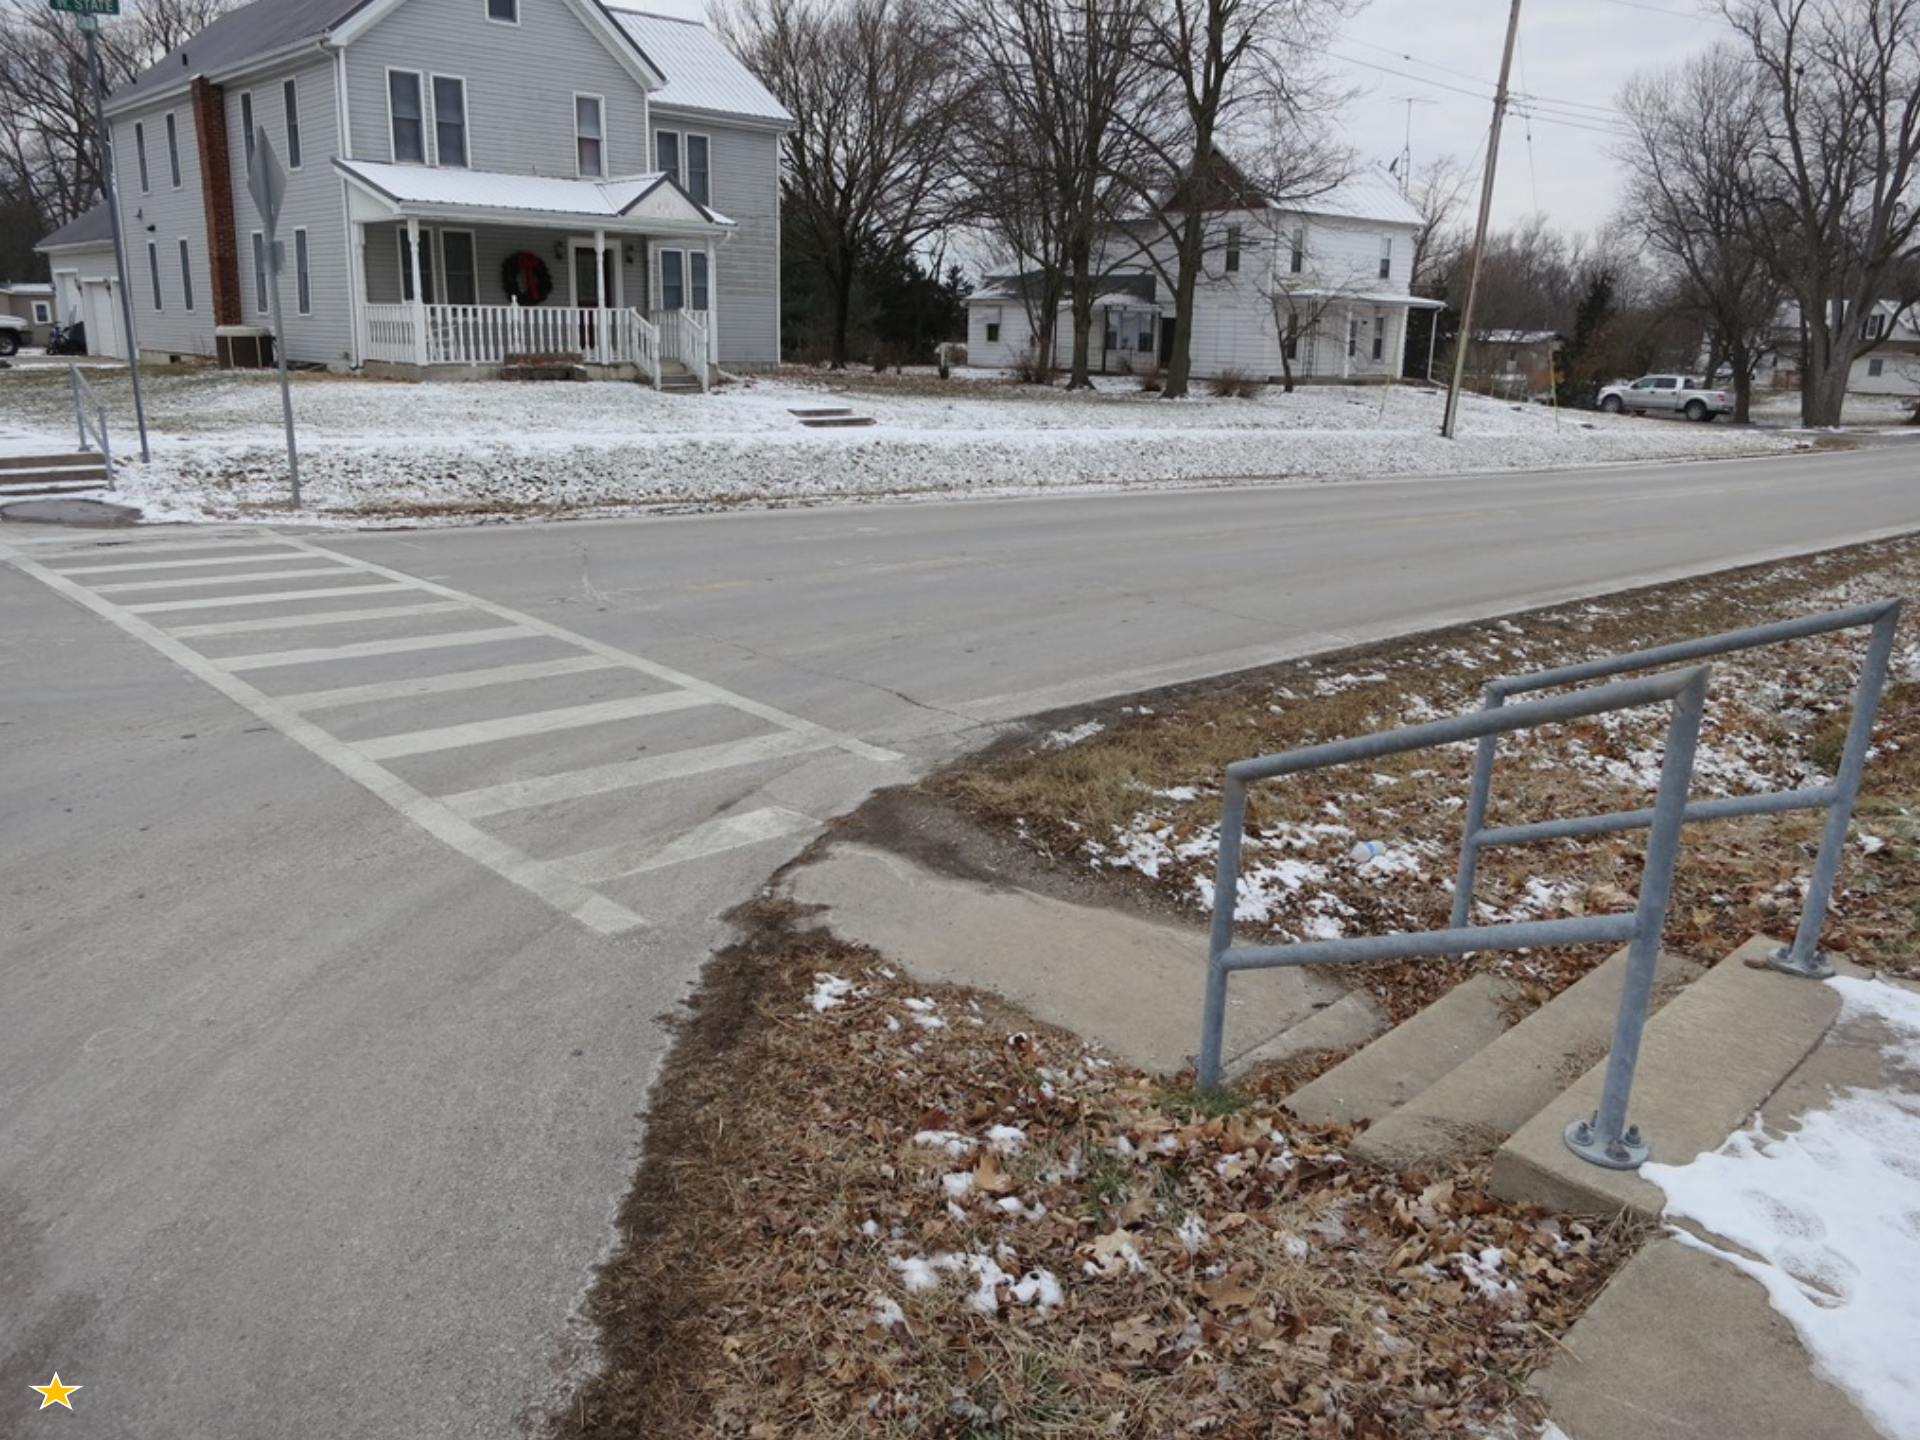
- Higher level treatments
 - (High-Intensity Activated crossWalk beacon (HAWK))
 - Rapid Rectangular Flashing Beacon (RRFB)
- ADA
- Lighting
