MARQUETTE INTERCHANGE PIER TS7

QA/QC Lessons
Learned, Case Study

Tony F. Shkurti, PhD, SE, PE

HNTB

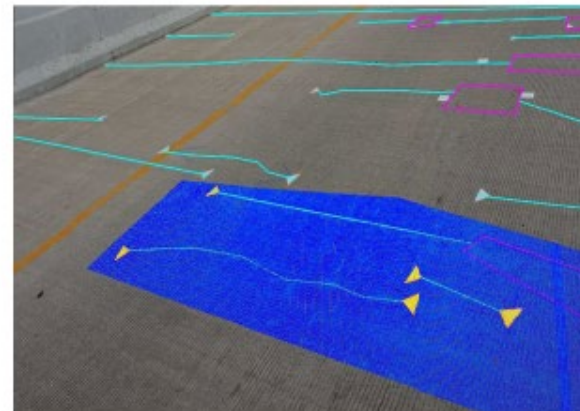
IMAGE WITH SCAN DATA
